**INTERIM REPORT  
ON WORK ON THE OUTWORKS BEYOND ST OSWALD'S GATE 2023**

**BRP End of Season Report**

April 2024

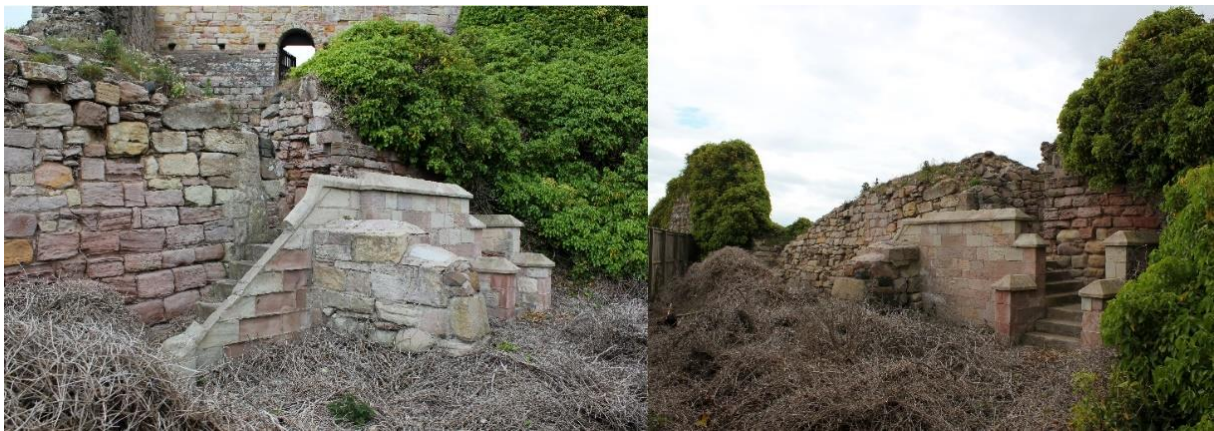
**Figure 4:** Two views of the late post medieval steps that approach the postern gate, facing north-east on right and north-west on left.

4.2.4. Inside the Western Postern the paved path, with several flights of steps (which appear of no great age), rise alongside the Wing Wall (**W2**) to a platform adjacent to an archway through the Wing Wall to a flight of steps dropping to St Elmund's Well Tower before the main flight of steps dogleg right to ascend to St Oswald's Gate (**Figure 4**).

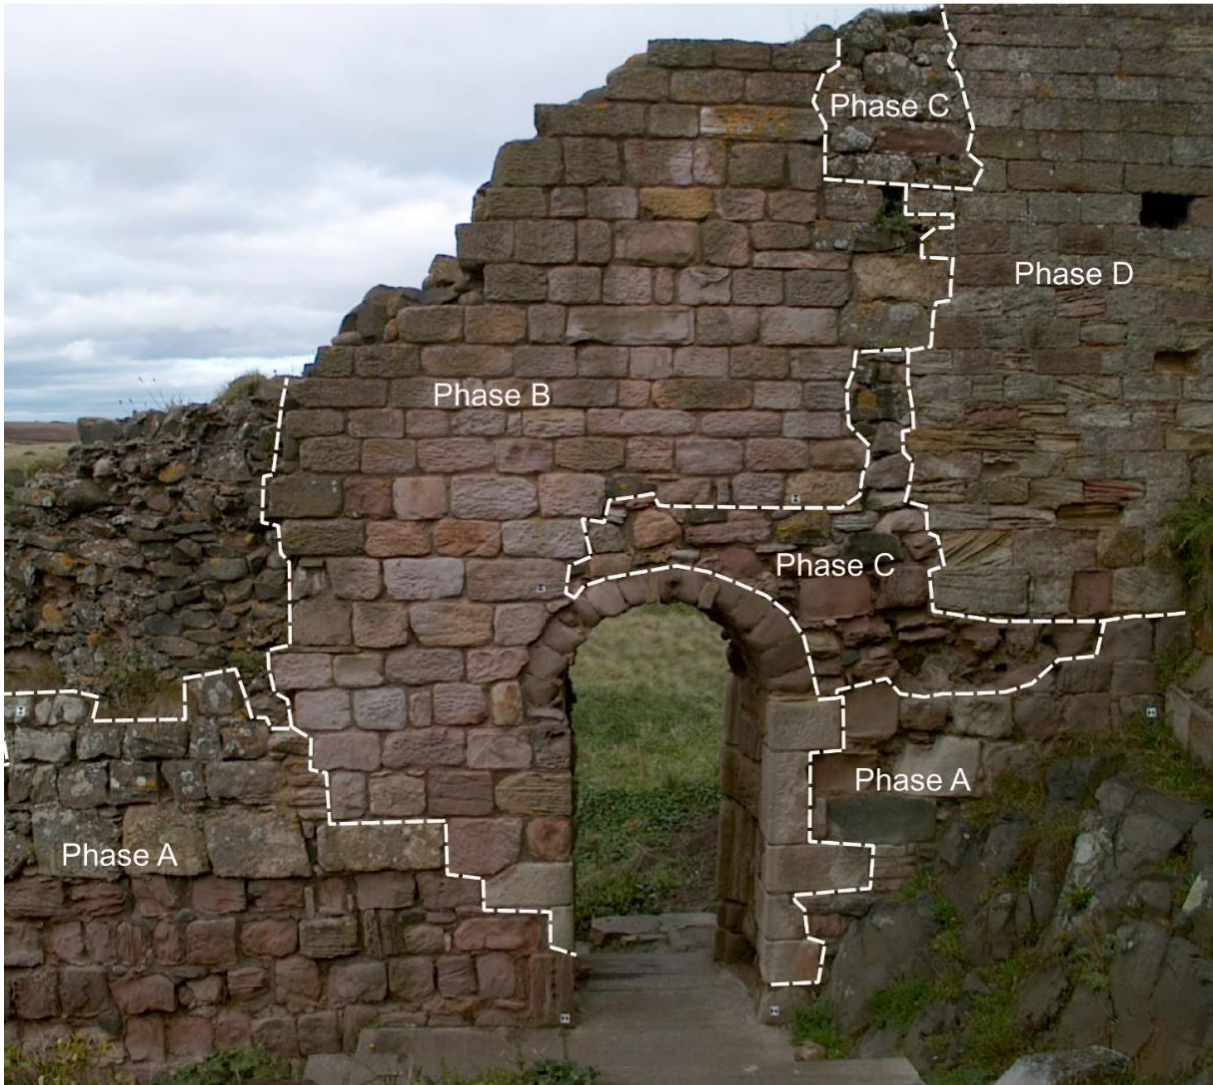
**Figure 5:** The narrow 'Wing Wall' showing the narrow archway and multiple phases of construction, facing north-west

many of these were accurate replacements. The fact that this opening is not in its original form is also suggested by the presence of a drawbar socket in the south-west jamb, but absence of any corresponding tunnel opposite

4.3.3. The outer (north-west) face of the Wing Wall shows the same four phases/areas of facing as the inner, the oldest masonry (with facing only surviving low down) being downhill of the arch. The neat square stonework of the uppermost section gives away its late date on this side by the way it overlaps the external face of the Curtain Wall and abuts on its core. An 1803 plan (Storer, J. Accessed via Northumberland Archives online 23/04/2024) seems to show the Wing Wall ending against the foot of the Curtain Wall glacis, which could mean that the section which over-rides the glacis is in fact 19<sup>th</sup> century work.

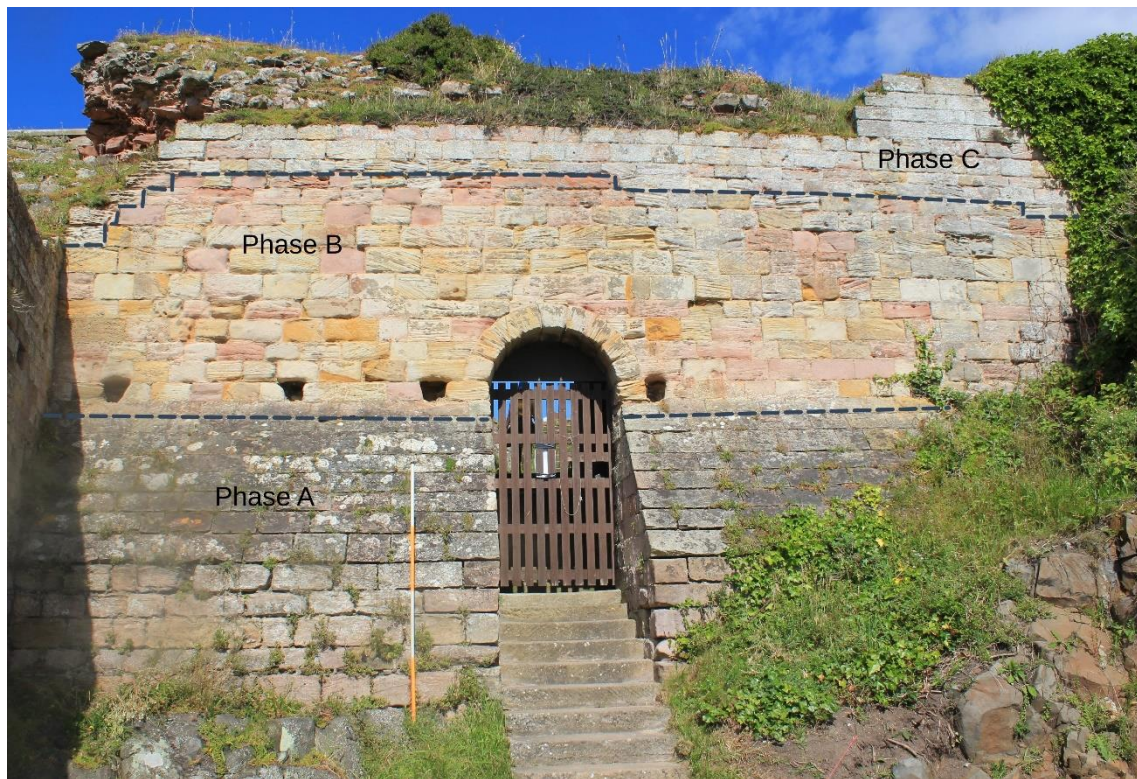
**Figure 6:** Exterior of the curtain wall showing phases, facing north-east

4.4.2. The gateway has a plain semicircular arch, with square-edged voussoirs; there is an internal rebate, with a drawbar tunnel in the north-west jamb but no sign of any corresponding socket beyond the sign of crude filling in on the opposite side in which a modern latch is set. The stone steps continue to climb through the gate passage, which has a slight offset on each wall at the internal ground level. The vault of the passage is considerably higher than the external arch, and seems to be in two parts, the first is of roughly two-centred in form and shows traces of plaster and may be medieval; the second (inner) is semicircular and is in close-jointed grey stone with a pecked finish. This goes with the plain semicircular internal arch and the whole internal face of the curtain as part of the Armstrong restoration.

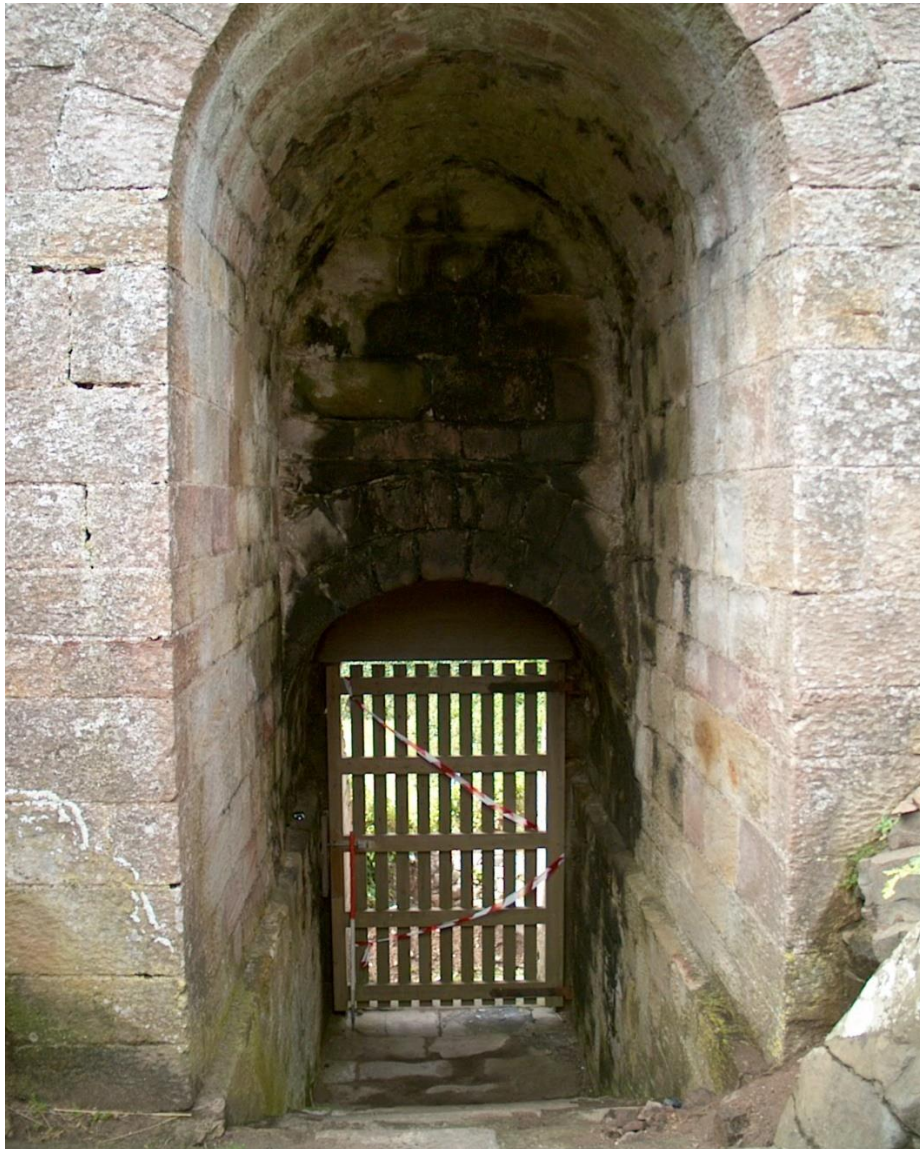
**Figure 7:** Interior of the curtain wall showing the vaulted passage and the interior of the gate arch, facing south-west

4.4.3. It is difficult to ascertain how much of the structure is genuinely medieval. The Northumberland County History (Bateson, E. 1893, 57), which describes the Castle before the Armstrong restoration, states that 'the postern itself has been refaced by Lord Crewe's Trustees'. The yellow stone of the outer wall face above is probably medieval as are, presumably, the open sockets which would have carried a brattice (timbers supporting a defensive external gallery) although there may have been some reconstruction. One might have expected the gateway arch to show some further defensive features (other than the one surviving drawbar tunnel) and evidence of door hanging. The upper courses, and the whole internal wall face (and inner part of the passage vault) are Sharp's 18th century work and their grey stone matches that of the glacis. This is clearly there on an 1803 plan and is probably Sharp's reconstruction of a genuine medieval feature (Storer, J. Accessed via Northumberland Archives online 23/04/2024).

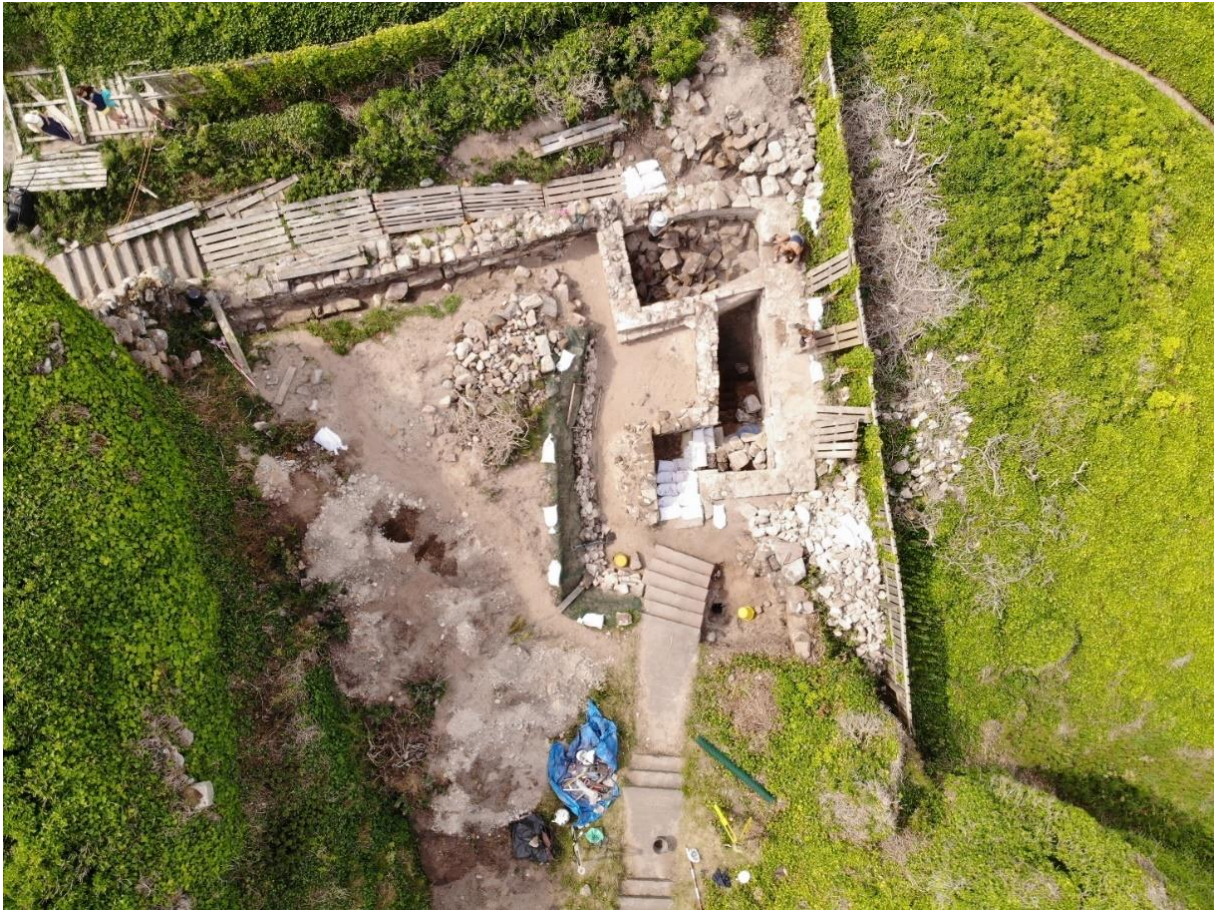
**Figure 8:** Aerial photo of the outworks with the cottage/tower seen in the top right corner. The steps that lead back to St Oswald's Gate, through the Wing Wall, at the bottom of the photo. Facing west

- 4.6.2. At the south-east corner of the structure is a small square entrance lobby, entered by an external doorway on the east. Two steps descend in the thickness of the wall to a landing, from which two further steps drop to the north to a further landing at the head of the main flight of a dozen or so steps, steep and now very worn, descending to the west, under a semicircular arch to open into the basement chamber. This is of rather irregular plan, around 3m north to south but less than 2m east-west, narrowing at its north end.

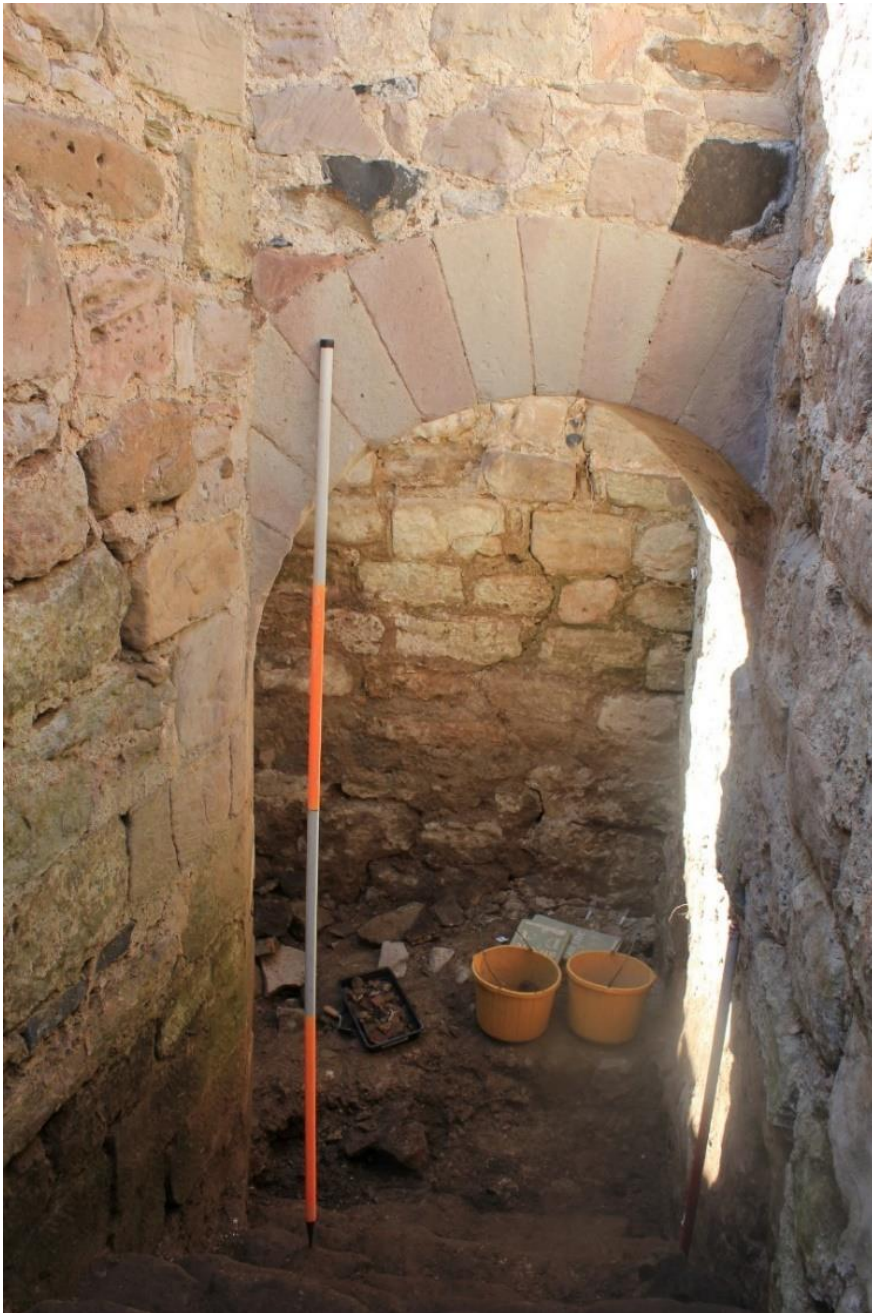
**Figure 9:** Archway leading to the basement of the Tower of Elmund's Well, facing west

- 5.1.3. **Figure 9**).
- 5.1.4. The archway had been well constructed and was a solid structure that showed little wear, unlike some of the stone in the corner of the wall beneath it. Perhaps, as with the windows, the archway may have been reused from elsewhere. The steps that led down to it were built more crudely and some had clearly been reused. They were also rather worn suggesting they were of some age.

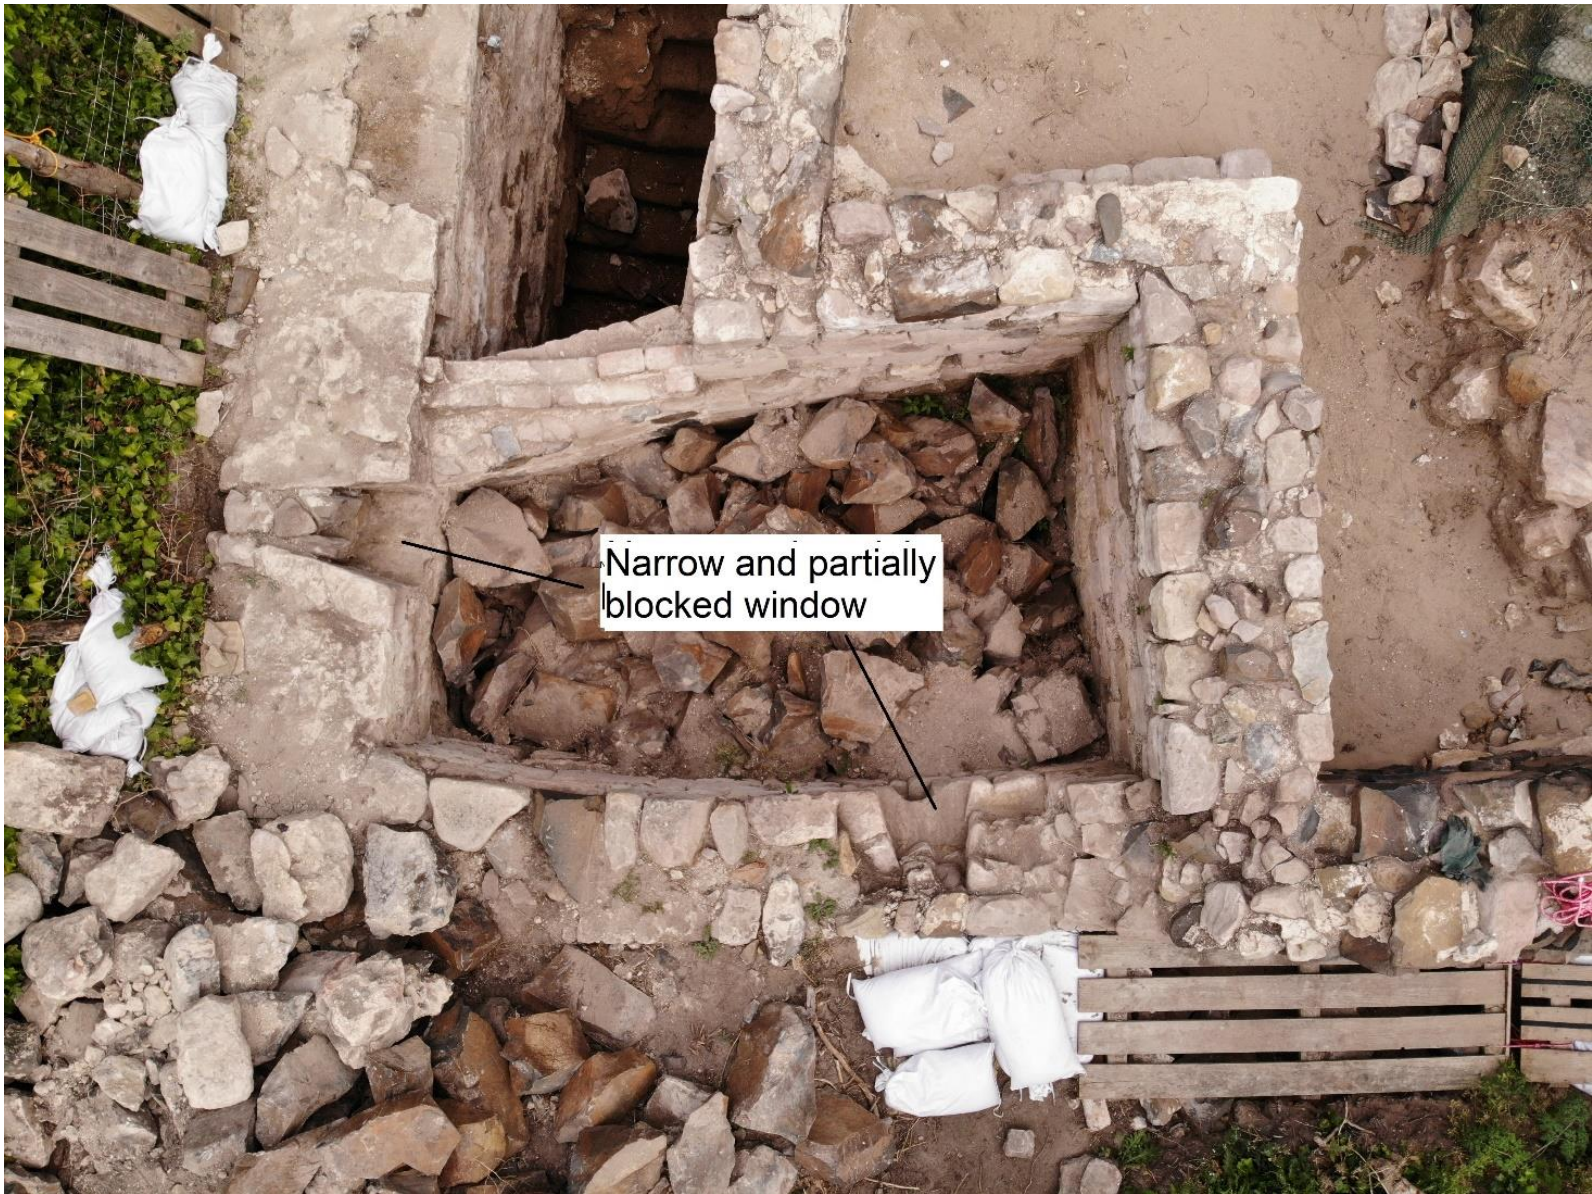
**Figure 10:** The tower from above showing the partially blocked narrow windows, facing east

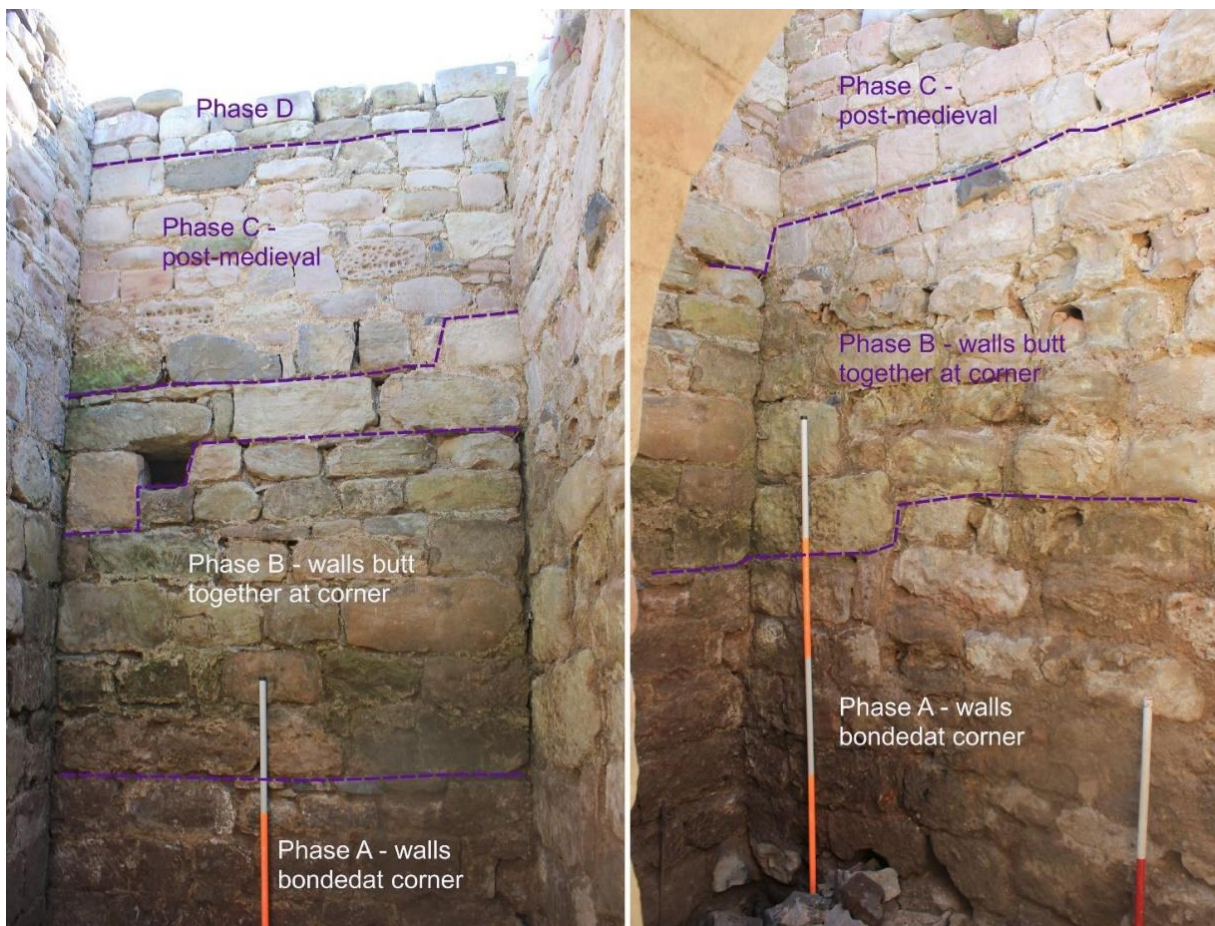
**Figure 11:** Two adjacent walls within the tower at the end of the 2023 excavation. The lower wall (right hand image) shows a change from the two walls keyed together and above the masonry butting. The upper wall (left hand side) shows at least two phases, C and D

4.6.8. The walls within the basement room have now been exposed to some considerable depth, well below the level of a single storey and show several build phases. The room oddly lacks right angles and is an odd shape making the interpretation of the build order and date of phases rather problematic. It is not even entirely clear if the tower was constructed as a stand-alone structure or constructed into an already existing enclosure outwork. At present the lowest exposed parts of the tower walls shows that the southwest corner, that is where the tower would be connected to the closing wall of the outwork, is keyed in at the lowest part that is exposed but shows a butt joint at a somewhat higher level above (**Figure 11**). The southeast corner, in contrast, is butt jointed at the lowest level making the build order unsure and making it hard be sure that the east wall is original even at this low level. The various types of masonry and phases present make the full interpretation problematic and very challenging and as a result the best chance will be when the tower is fully uncovered and further trenches external to the tower are able to define the core medieval structures from the later cottage reconstruction.

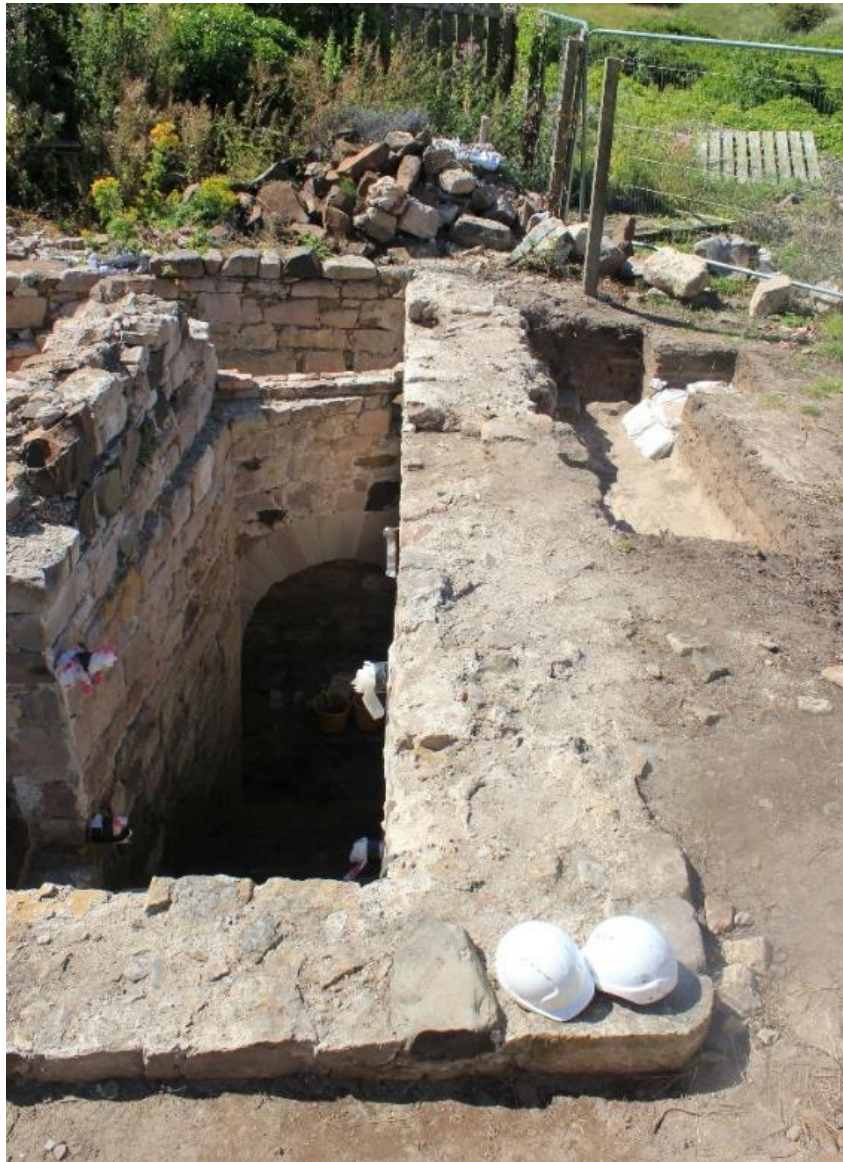
**Figure 12:** North wall of the cottage/tower showing Trench 7F on the outside where the full width of the wall has been encountered at around 0.6m deep, facing west

- 5.1.7. A new trench (Trench 5F) was started this season on the seaward side of the tower structure and has already removed a considerable volume of wind-blown sand. This was sited to give us a proper understanding of the width of the wall, the top of which had been altered substantially when the tower was converted into a cottage. Here, less than a metre down, we found that the wall survives wider than it appears at the top, where some facing stones had been removed. We will continue, and further extend this trench during the 2024 season, in the hope of uncovering buried ground surfaces (Figure 12).

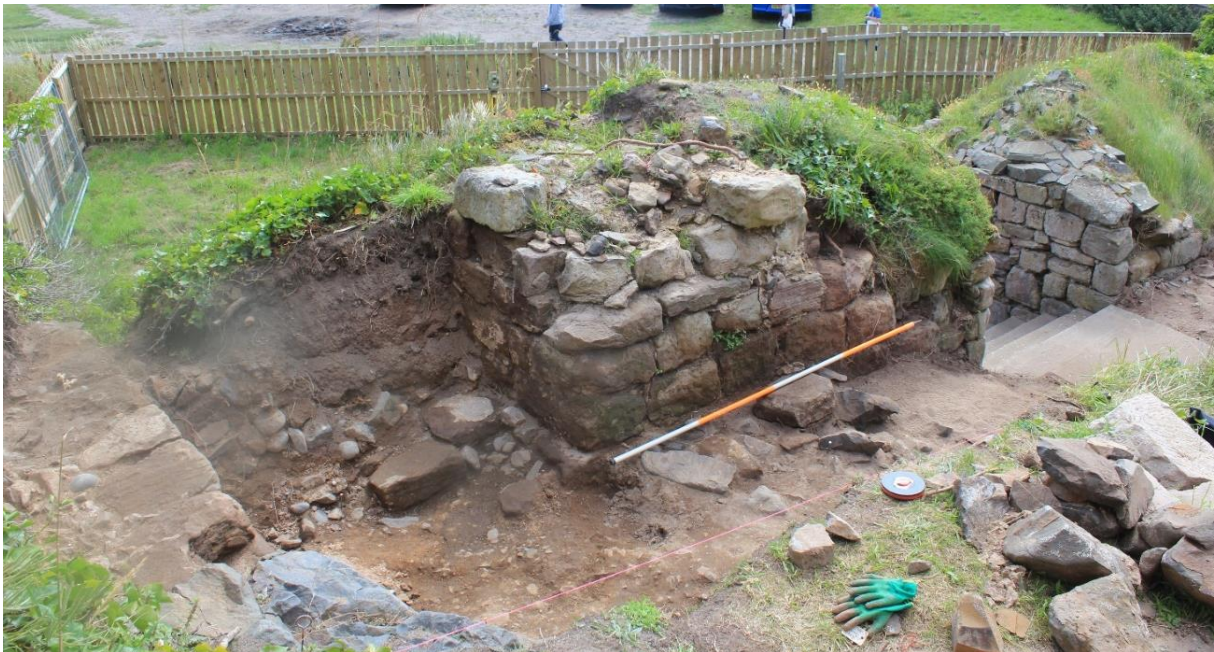
**Figure 13:** The recently discovered blocked doorway in wall W1 (see **Figure 2**) with some of the blocking still in place, facing south-west

5.2.1. There was further work on the postern gate that lies beyond St Oswald's Gate that leads out to the village. Continued excavation immediately behind the wall that leads back to the castle rock has uncovered more of the structure. The intent for this was to uncover more of the wall, recover some datable finds and identify the level from which it was constructed. The structure as uncovered was a single well-constructed feature of coursed squared masonry that ended abruptly and deliberately short of the rock. A further constructed face abutted the bedrock and the two faces formed a 1m wide gap that has been interpreted as a second gate (**Figure 13**).

5.2.2. The outside face that looks out to the village had been blocked by a single layer of masonry backed by soil and rubble to close off the gap. It was also evident that it was quite high up (on the outside) as it bottomed onto a spur of the bedrock. This means the gate was at ground level on the inside but a couple of metres above it on the outside. There is no trace of a stair up to it, so it seems likely that there would have been a wooden stair, which perhaps would have made it a little more defensible as it could be discarded in the face of an enemy.

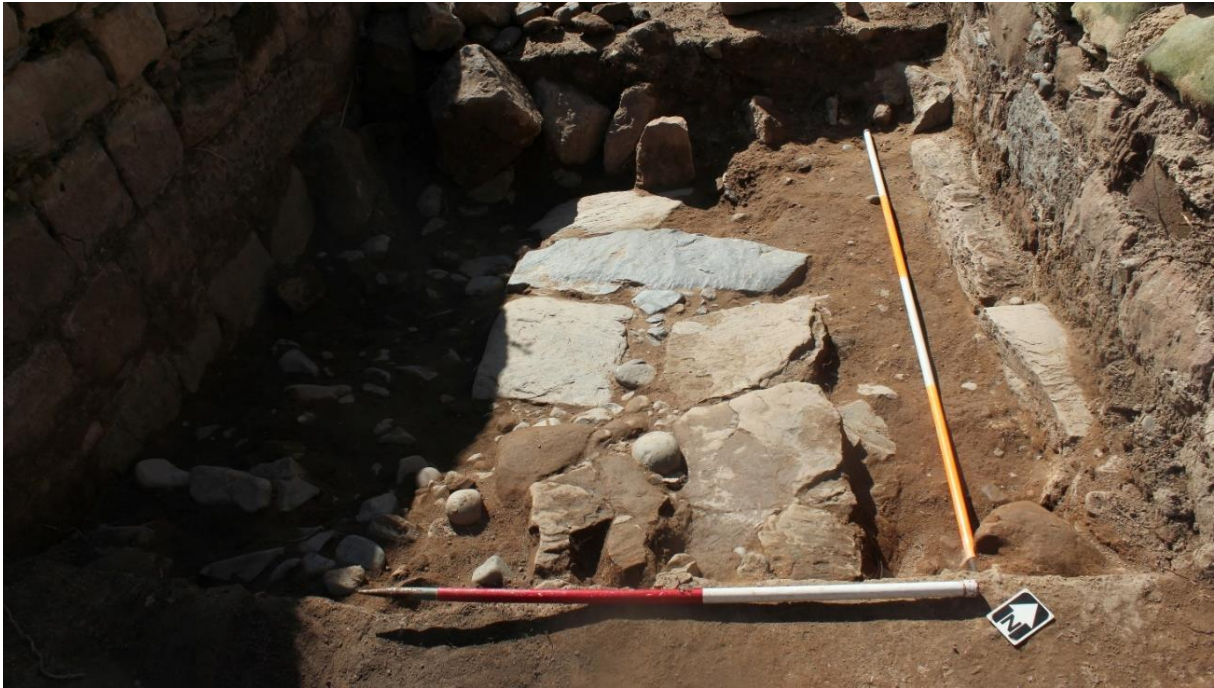
**Figure 14:** The newly discovered stone feature in Trench 5E, facing west

5.3.2. It has revealed a stone alignment that extends parallel to the two standing walls. Those of the outworks and the short wall length. So far only the upper level has been uncovered, so it is possible that it could be either a wall top or a foundation or the surface of a narrow path (**Figure 14**).

5.3.3. The feature is made of dolerite and sandstone and in this, along with its width and general form, it is very reminiscent of some of the early medieval features that we have excavated within Trench 3 in the West Ward of the castle. Here these features occurred low in the stratigraphy and have been interpreted as stone foundations for timber walls. It is that we are seeing the same kind of feature here in the area of the outworks, potentially of similar early medieval date? One of the questions we asked ourselves at the beginning of the work on the outworks was 'could we find any evidence for structures and arrangements from the early medieval period?' We know the entrance was in use from this time and likely centuries earlier, so there must have been access routes and perhaps structures associated with this period of use.

- 6.1.3. The final trench of the season Trench 5E has produced what may be the most interesting and enigmatic feature of all. Identified only close to the end of the season it appears to be a foundation rather than a path or surface but one of crude form that could possibly be of early character. It extends broadly parallel with the adjacent outwork south wall **W1** and was of a similar width to the cross wall **W2** (**Figure 14**). It will be interesting to see how far the feature extends, or

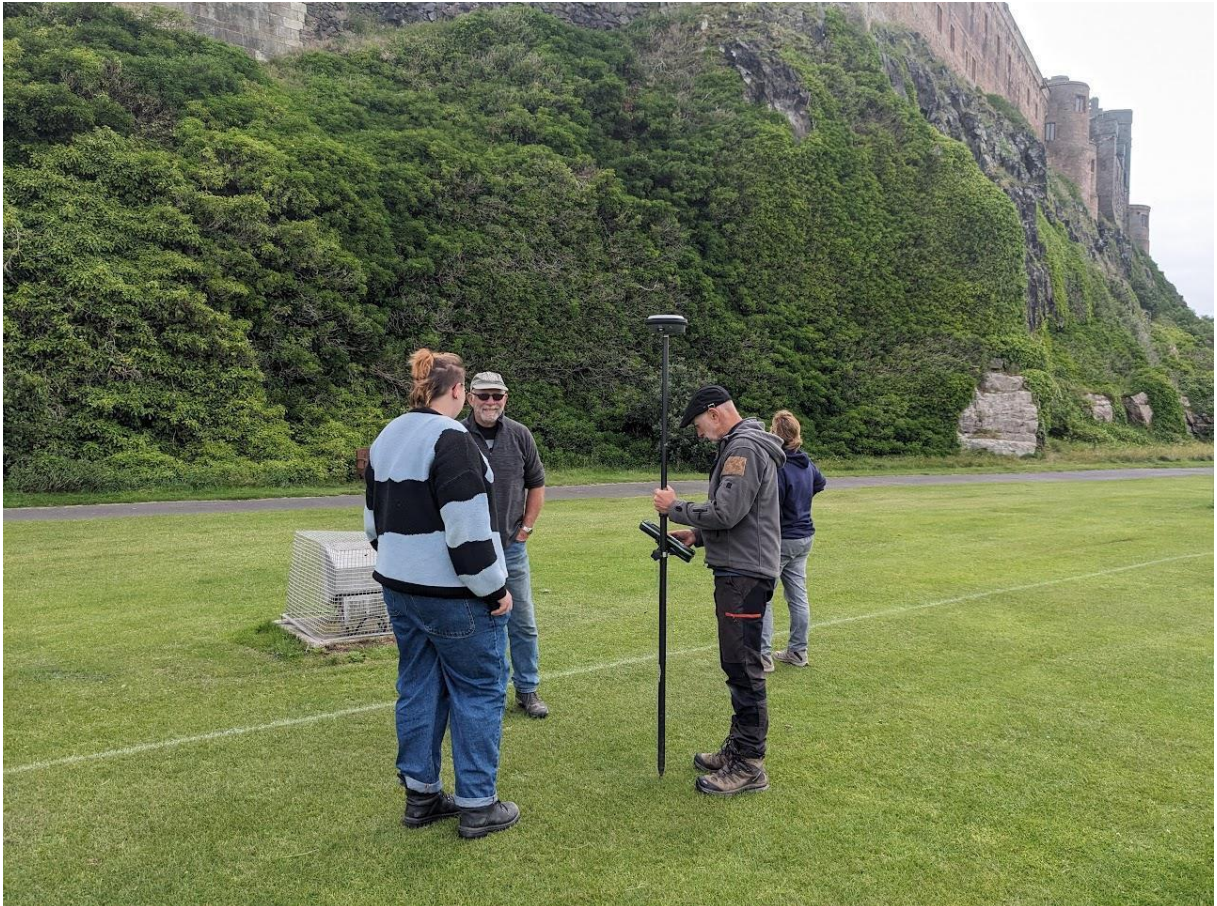
**Figure 15:** Volunteers from the Bamburgh Research Project using the GPS to establish a survey grid in the Cricket Ground (photo: K. Strutt)

7.5.1. For the survey at Bamburgh, a grid system was established using a Leica Viva Real Time Kinetic (RTK) GPS (Figure 15) utilising the Ordnance Survey coordinate system OSGB36. Wooden survey pegs and spray markers were set out at 30m-by-30m intervals, and the grids for all areas were georeferenced with the OS grid system through the Smartnet function of the GPS.

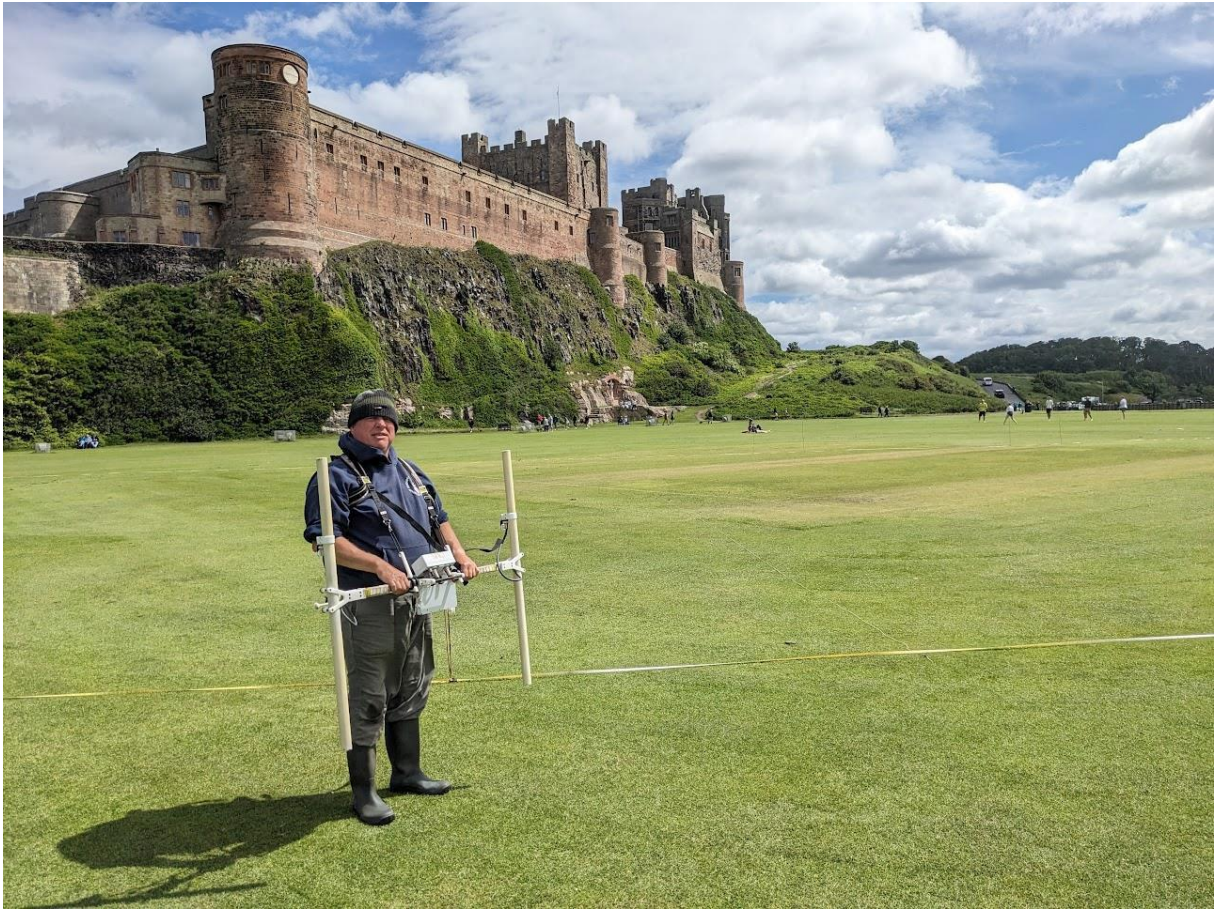
**Figure 16:** Dominic Barker using the Bartington Grad 601-2 instrument on the Cricket Ground (photo: K. Strutt)

7.5.2. The magnetometer survey was conducted using a Bartington Instruments Grad 601 dual sensor fluxgate gradiometer (Figure 16). Measurements were taken at 0.25m intervals on 0.5m traverses, with data collected in zig-zag fashion. The survey data were processed using Geoplot 4.0 software. The processing of data was necessary to remove any effects produced by broad variations in geology, or small-scale localised changes in magnetism of material close to the present ground surface. Magnetometer data were despiked to remove any extreme magnetic values caused by metallic objects. A zero mean traverse function was then applied to remove any drift caused by changes in the magnetic field. A low pass filter was then applied to remove any high frequency readings, and results were then interpolated to 0.5m resolution across the traverses.

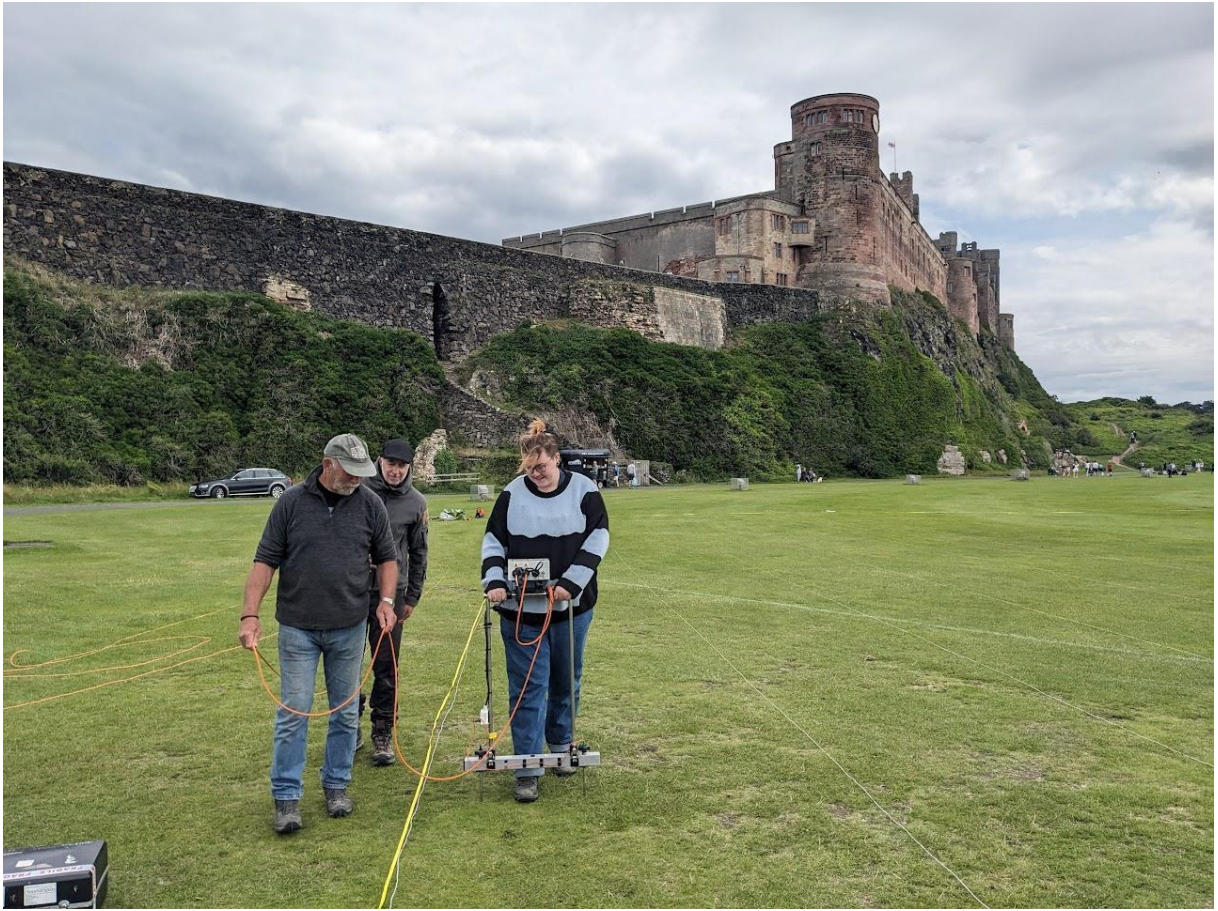
**Figure 17:** Earth resistance survey being carried out by BRP volunteers (photo: K. Strutt)

7.5.3. Earth resistivity was carried out using a Geoscan Research RM15 resistance meter, with measurements taken at 1.0m intervals along traverses spaced 1.0m apart (**Figure 17**).

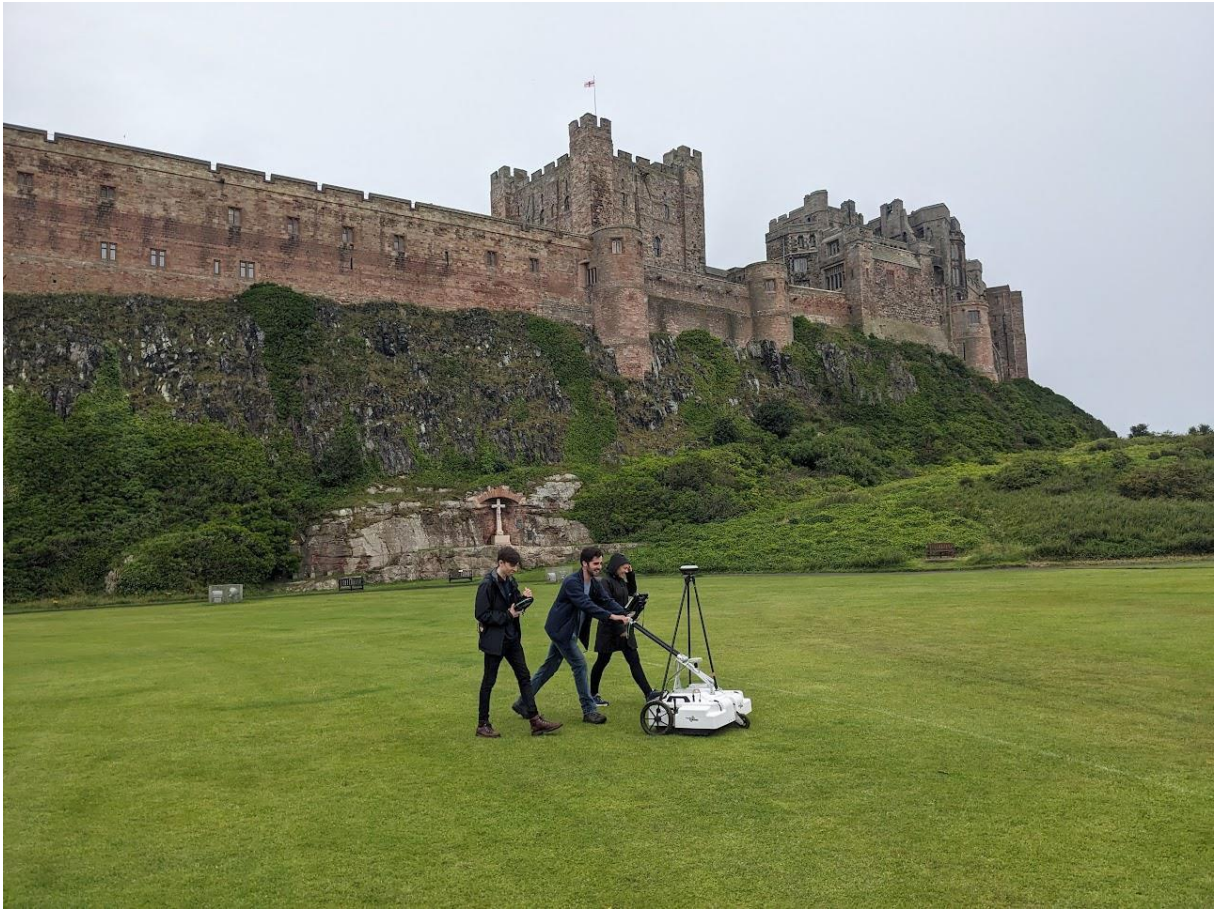
**Figure 18:** GPR survey under way across the Cricket Ground using an Impulse Raptor 8-channel system and GPS (photo: K. Strutt)

7.5.4. The Ground Penetrating Radar (GPR) survey was carried out using an Impulse Raptor 8-channel system, set up to collect data and establish location using a the RTK GPS (**Figure 18**). The spacing between channels was 0.125m with traces initiated at every 0.05m along each traverse. Data were processed using GPR Slice software. The different survey profiles were presented in their relative positions, and all profiles were then processed to remove background noise. A bandpass filter was applied to each profile to remove all high and low frequency reading, and a Hilbert Transform was also applied to increase the strength of responses when the data were sliced.

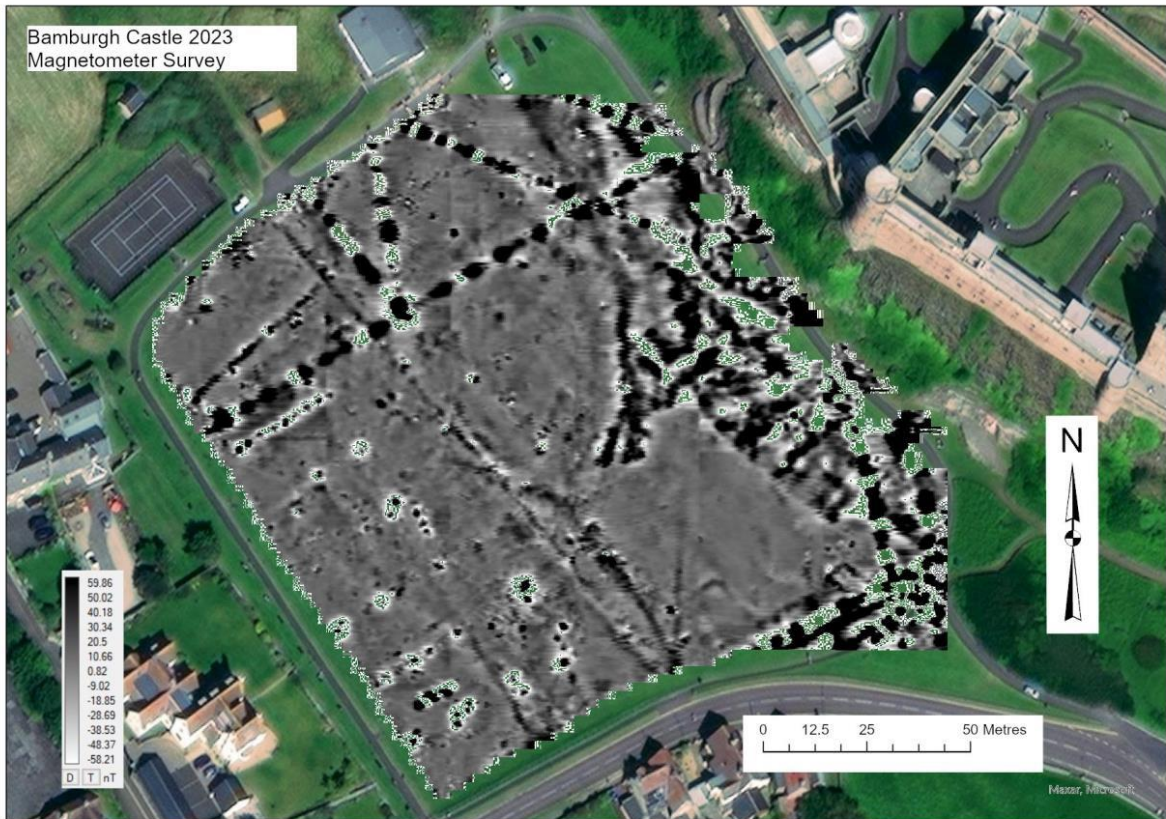
**Figure 19:** The magnetometer survey of the sports field georeferenced to the modern map with Google Earth imagery beneath  
Map Data: Google ©2023, Airbus 11/05/23

trackways, with a further linear anomaly indicating the line of a wall [m13], matched by a number of possible wall features in the south [m14] and west [m15] and [m16] of the area.

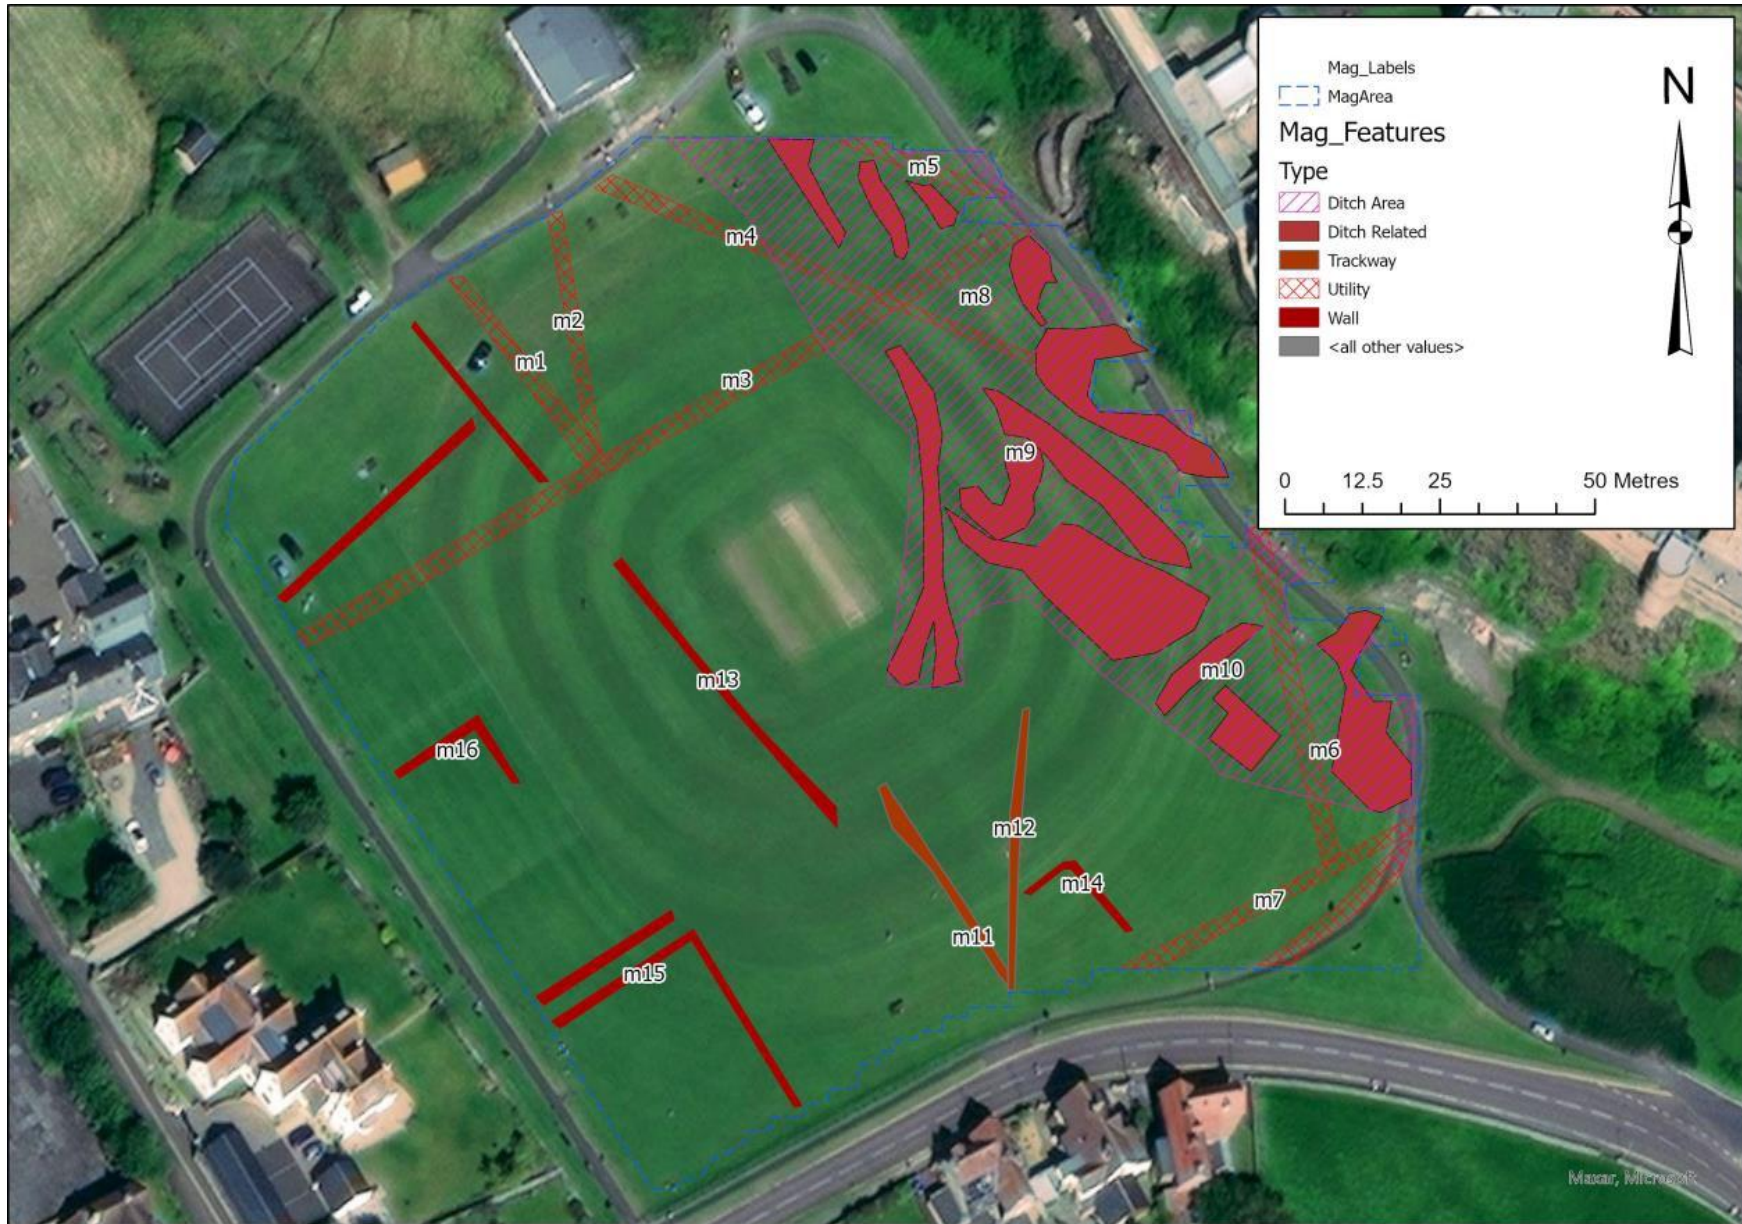
**Figure 20:** Interpretation of the magnetometer survey. Map Data: Google ©2023, Airbus 11/05/23
