**INTERIM REPORT  
ON WORK ON THE OUTWORKS BEYOND ST OSWALD'S GATE 2023**

**BRP End of Season Report**

April 2024

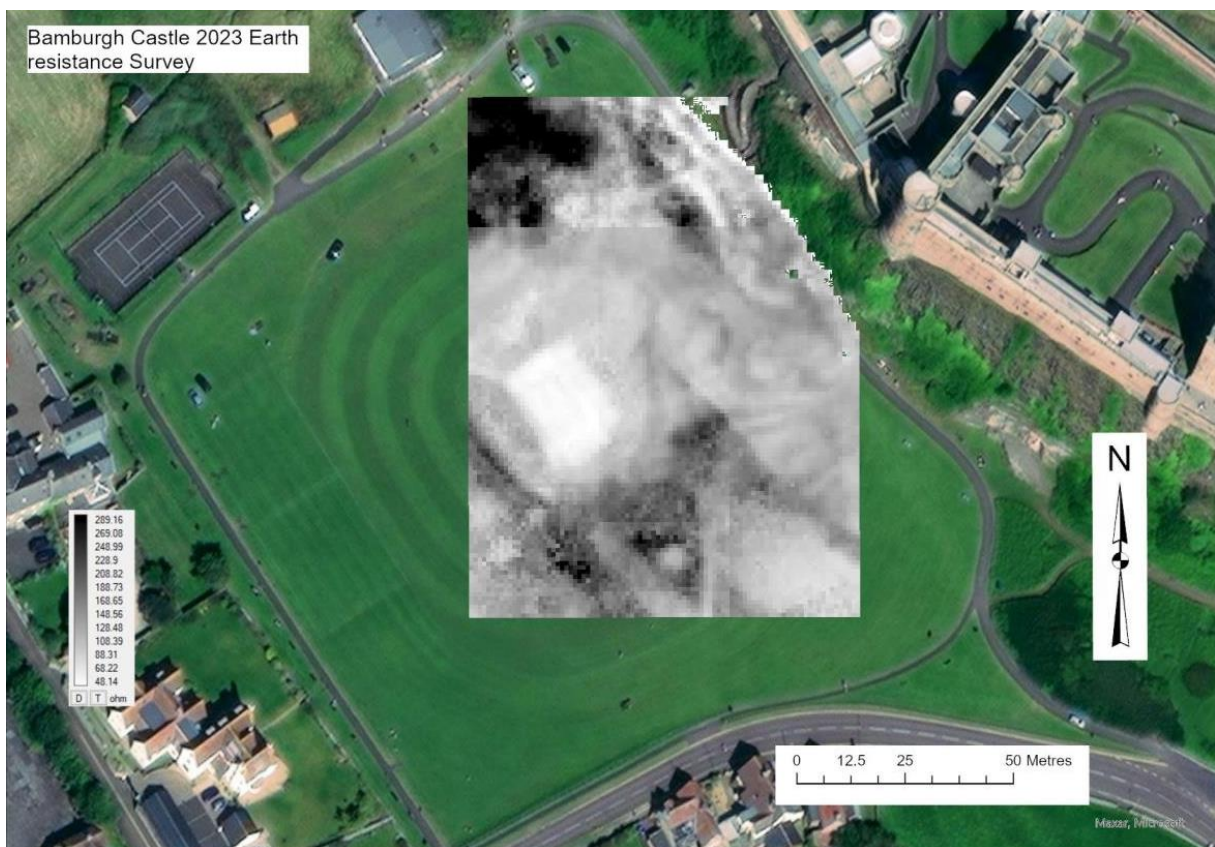
**Figure 21:** Results of the earth resistance survey  
Map Data: Google ©2023, Airbus 11/05/23

7.6.3. A smaller area of earth resistance survey was conducted during the season (Figure 21, Figure 22), and with a 0.5m twin probe array being utilised, provides a relatively shallow set of data for the area. The results are dominated by the low resistance responses of the modern cricket square **[r1]** caused by the difference in the shallow deposits across the cricket square, and presumably from the maintenance and treatment of the square over many years. Evidence for the castle ditch, and high resistance deposits to the west **[r2]** and **[r3]** are evident, presumably the latter caused by sandy material. The two trackways are evident **[r4]** and **[r5]** as two low resistance linear anomalies. The wall associated with one of the trackways **[r6]** is also visible as a high resistance linear feature.

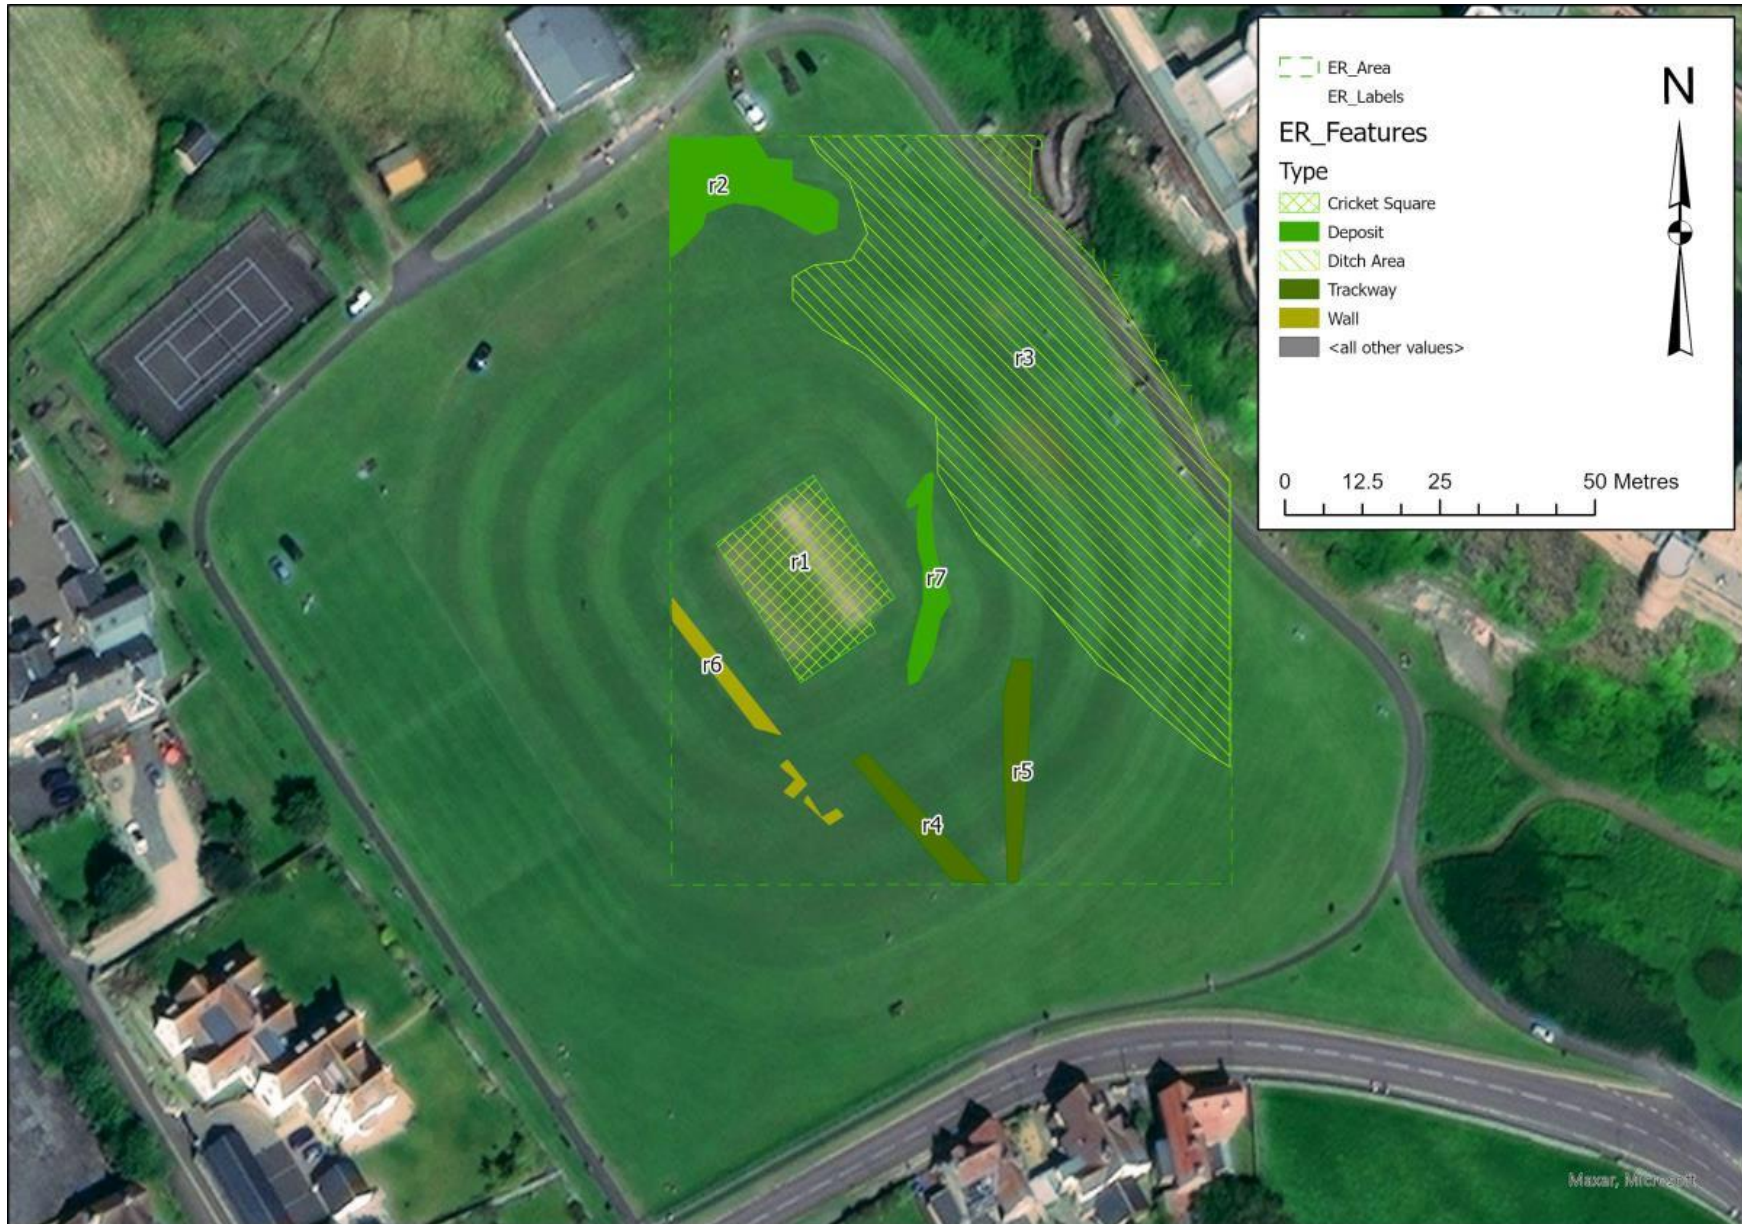
**Figure 22:** Interpretation plot for the earth resistance survey. Map Data: Google ©2023, Airbus 11/05/23

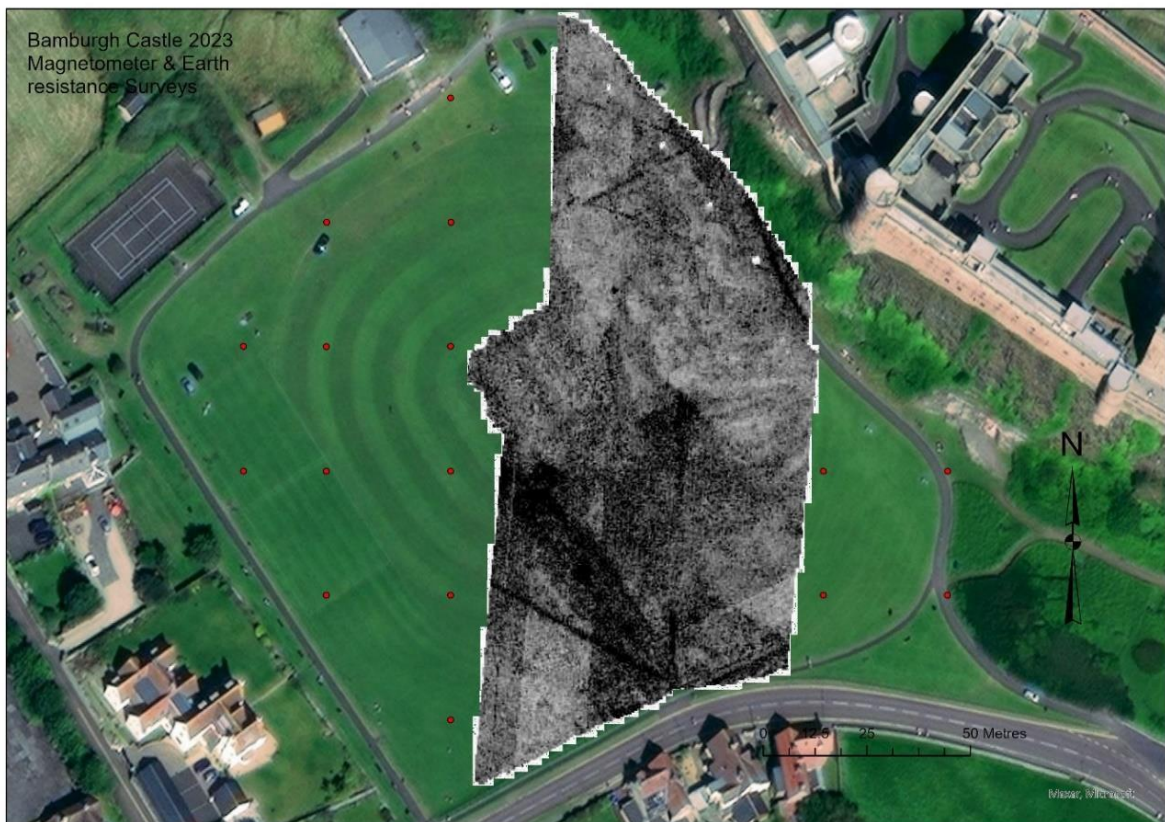
**Figure 23:** Results of the Ground Penetrating Radar (GPR) Survey. Map Data: Google ©2023, Airbus 11/05/23

7.6.4. The results of the GPR survey (**Error! Reference source not found.** Figure 24) indicate anomalies that match the utilities mapped in the magnetometry **[g1]** – **[g3]**. In addition, the area of the castle ditch is clearly visible as a low amplitude area **[g4]** measuring over 45m in width. What is interesting is that the cut of the ditch is not clearly represented in the data, but there is a contrast in the subsoil between the ditch area and the rest of the survey area that defines the feature. The ditch is also defined slightly by the line of a possible trackway **[g5]** and **[g6]** that in the data runs up to the edge of the ditch but is then not visible further to the north. The trackway visible in the earth resistance can also be seen **[g7]** running north-west, together with two further linear anomalies **[g8]** and **[g9]** suggesting possible surfacing or trackways.

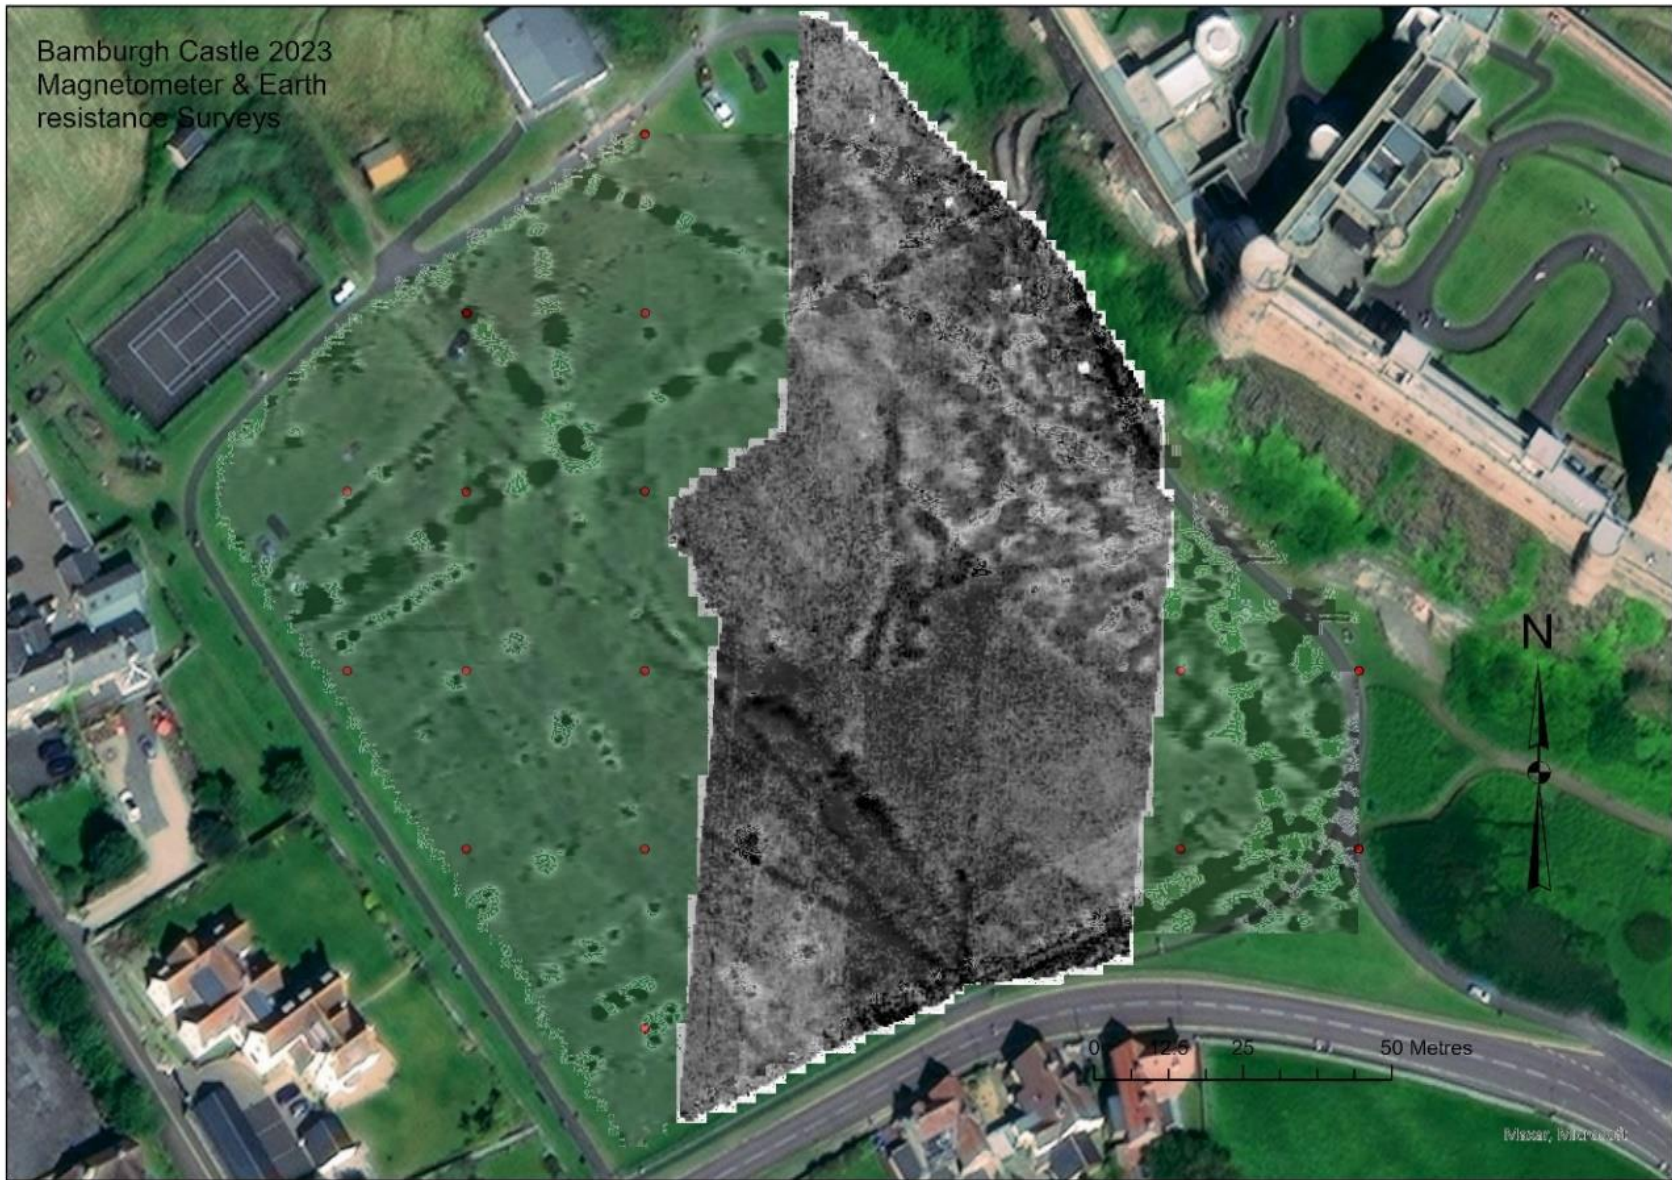
**Figure 25:** Overlaid transparencies of the magnetometer and GPR result . Map Data: Google ©2023, Airbus 11/05/23

- 8.1.4. The GPR results suggest a large ditch, some 45m across at its largest extent, and 40m at its narrowest, comparing with the extant remains of the ditch to the east of the cricket ground which measure c. 36m across. The feature seems to be at least 2.5m deep at the centre, and possibly much deeper as the GPR signal attenuated before picking up the base of the feature. The GPR results, while indicating the extent of the ditch, show very minor changes in terms of background measurements, suggesting a degree of homogeneity in the form of the sub-soil and the backfilling of the ditch. This is also apparent in the earth resistance survey, in which the 0.5m twin probe array, giving shallow readings, shows limited contrast between the ditch fill and the surrounding area. Crucially greatest contrast for both methods shows where near-surface anomalies to the west and south of the ditch provide clear evidence for the edge of the feature. In the earth resistance and GPR (**Figure 26**) the edge of the feature seems relatively smooth. However, in the magnetometry (**Figure 25**) the strong magnetic anomalies show a more irregular form, potentially due to them representing deeper magnetic deposits, or cutting into underlying bedrock.

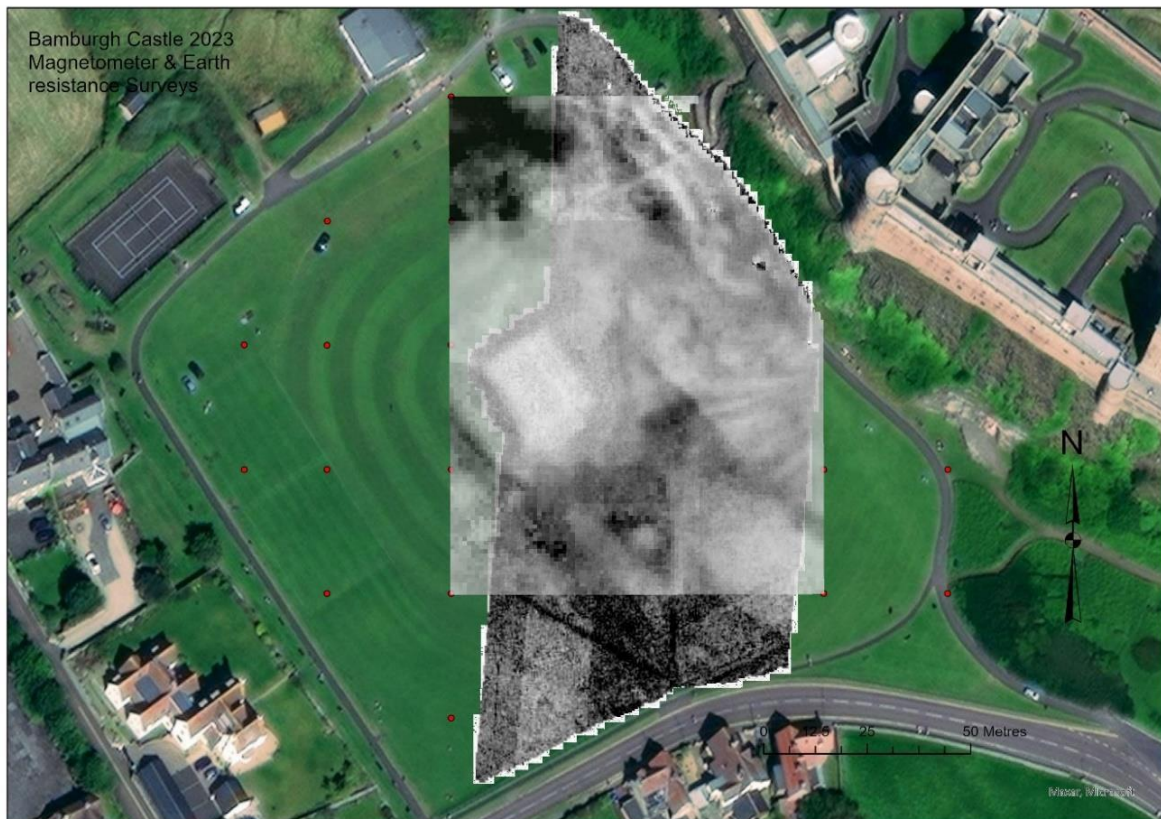
**Figure 26:** Overlaid transparencies of the earth resistance and GPR results.  
Map Data: Google ©2023, Airbus 11/05/23
