ARCHAEO-TOPOGRAPHICAL SURVEY CAUS CASTLE, WESTBURY SHROPSHIRE A preliminary report

Michael Fradley and Giles Carey
December 2016

SUMMARY

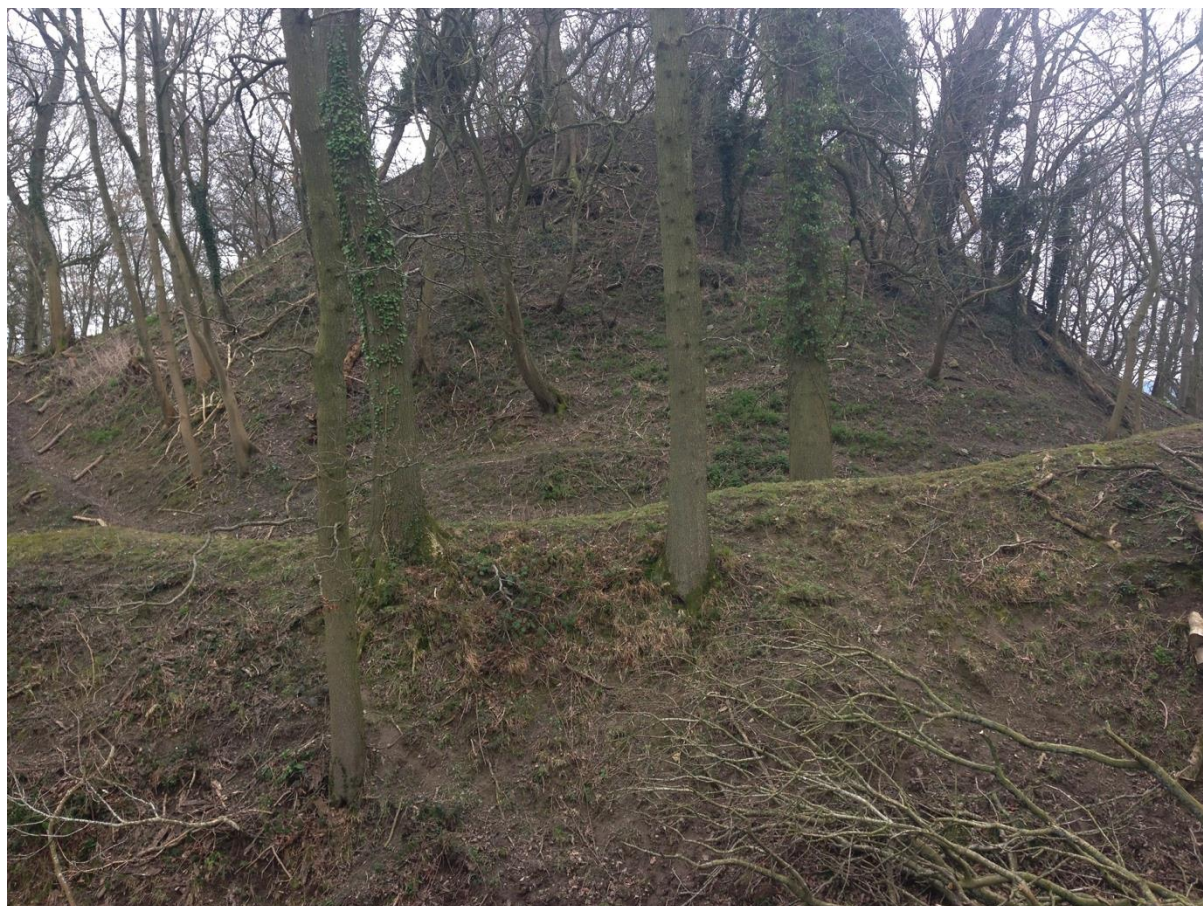
Caus Castle motte, viewed from the north-west

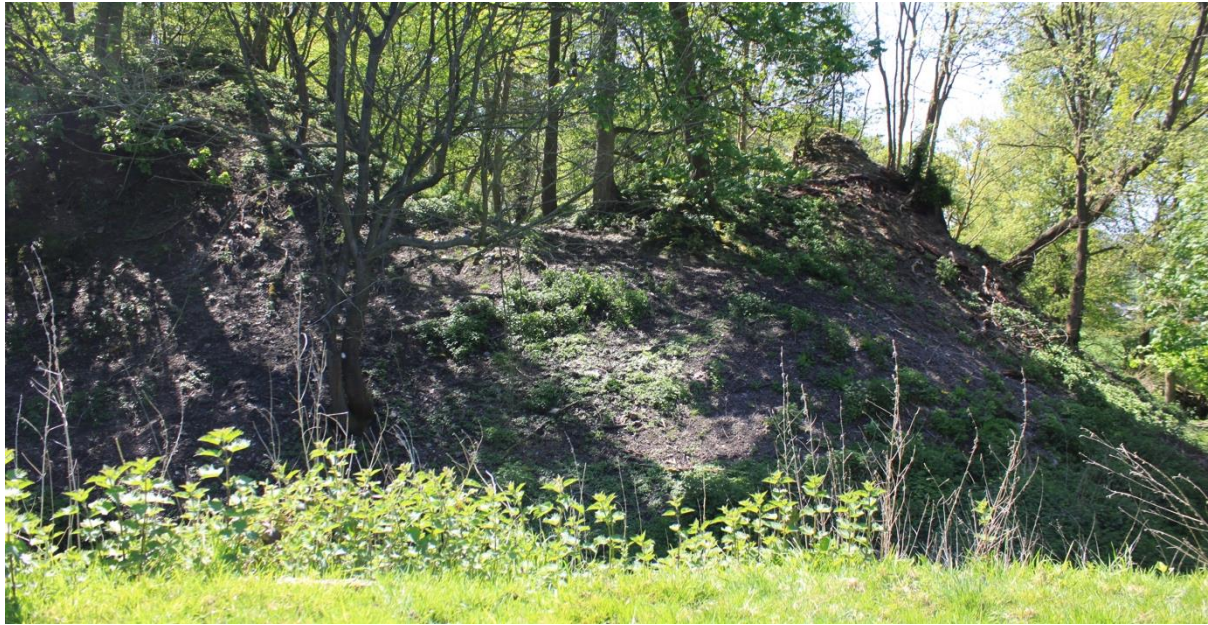
Figure 4. The entrance to the inner bailey viewed from the north-east, from a position in the outer bailey.

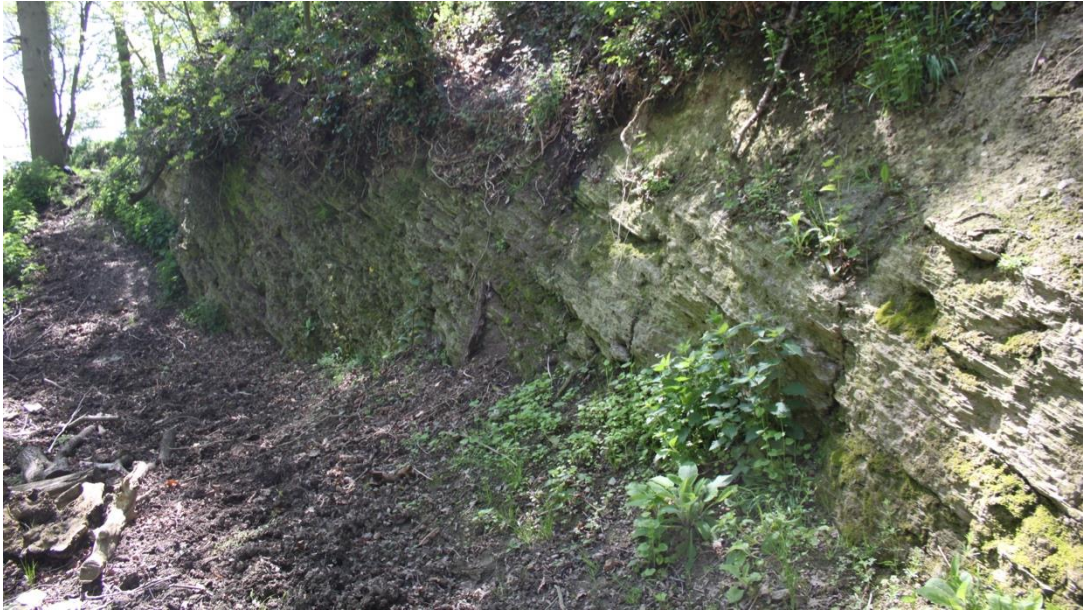
Figure 5. The rock-cut ditch on the west side of the motte.

The castle is surrounded by a large ditch, varying in width from c.10-20m and up to 6m in depth. Around the south-western and north-western sides of the castle is a smaller outer ditch measuring c.7-14m wide, the outer of which partially consists of a counter-scarp bank. This outer ditch widens significantly on the south-western end as it reaches its terminus, at which stage a near-continuous stretch of bank runs up to the inner castle ditch, possibly indicating the existence of a rear entrance into the castle compound. Inside the inner and outer ditches of this area are a large face of rock-cut mudstone surface (Fig. 5), and possibly the origin of some of the masonry fragments still identifiable on the ground at Caus. The position of this rock outcrop suggests that it continues beneath the motte, and that the latter mound may have been built over an outcrop on the summit of the hill.

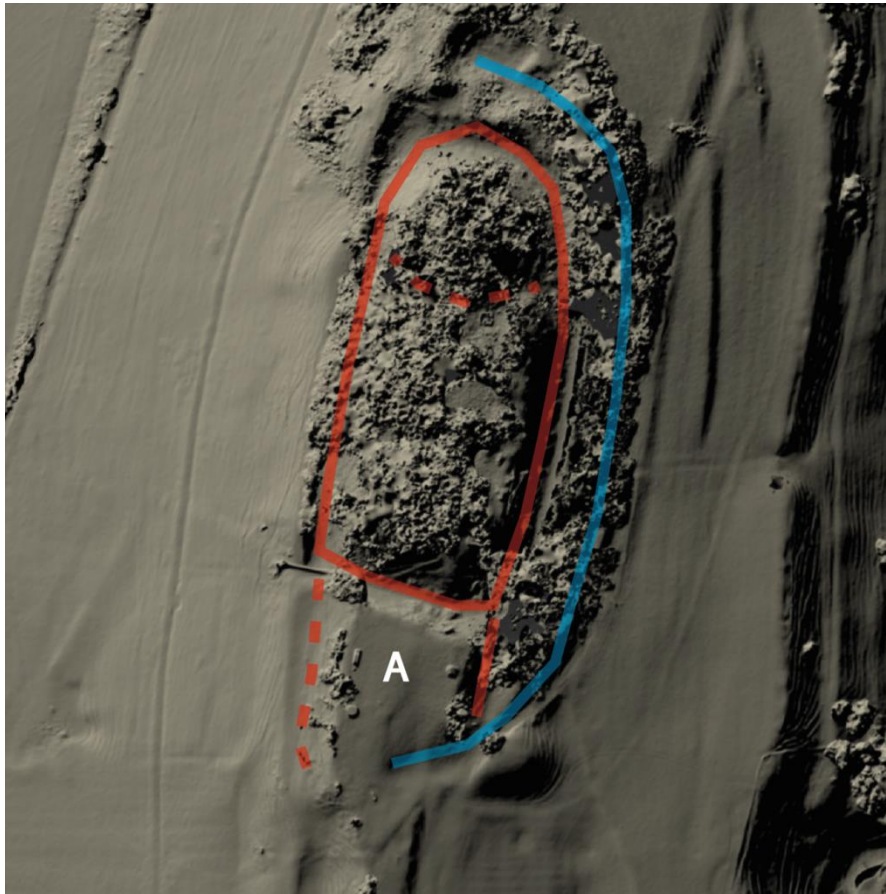
Figure 6. An interpretive scheme of the castle layout, with the motte defined at the top of the complex, the inner bailey in the centre and the outer bailey at the bottom (A). This simple delineation would suggest that the outer bailey came into existence with the cutting of the second, outer ditch on the north side of the castle (shown in blue), but the evidence is so distorted that it is feasible that the outer bailey was an original feature of the first castle constructed on the site (original model by Adam Stanford).

One of the most interesting details recorded as part of the survey project are a number of slight depressions at the north-east end of the castle area. These seem to indicate the in-filled remnants of an outer ditch that would have enclosed a smaller outer bailey area (Fig 6: A). This interpretation is given

further support when considered as part of the wider castle layout, particularly its ditch system and the position of potential garden features on the south side of the castle discussed further below. It appears that this area of the castle has been heavily remodeled and the ground level potentially increased in height, possibly as part of the post-medieval investment in the site by the Thynne family. It has generally been assumed that the outer enclosure formed a large outer bailey to the castle, but this is potentially overturned by this new data.

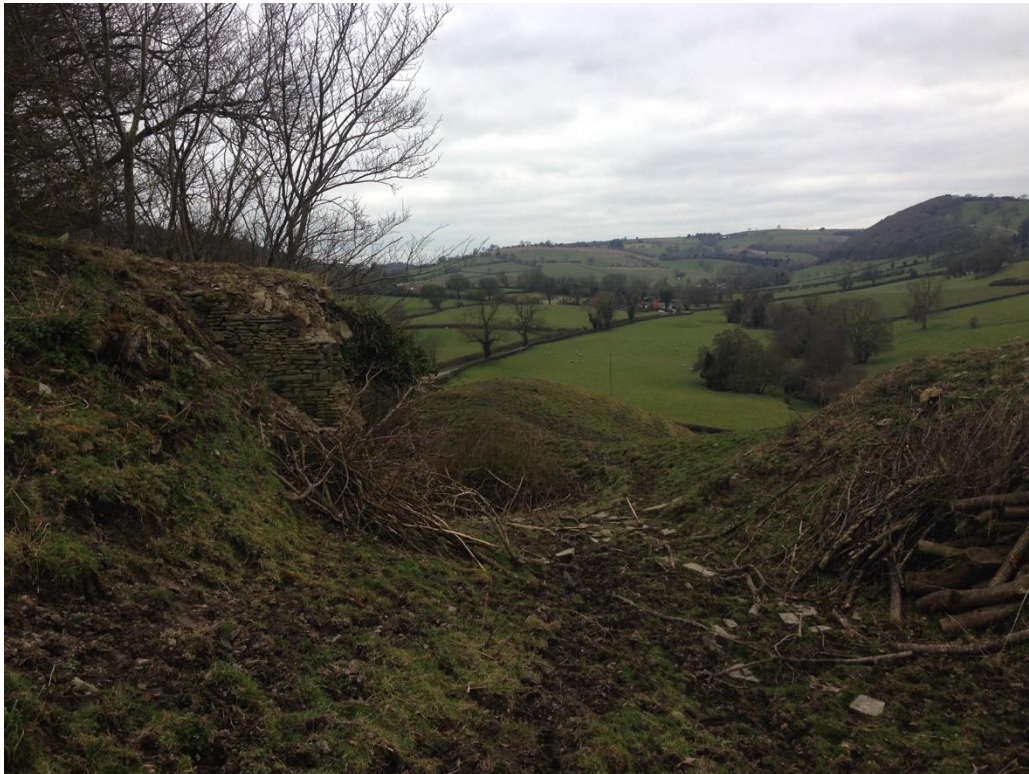
Figure 8. The Wallop Gate with a hollow-way leading westwards out of the castle into valley beyond. The slight masonry mains of the gate can be seen on the left of this image.

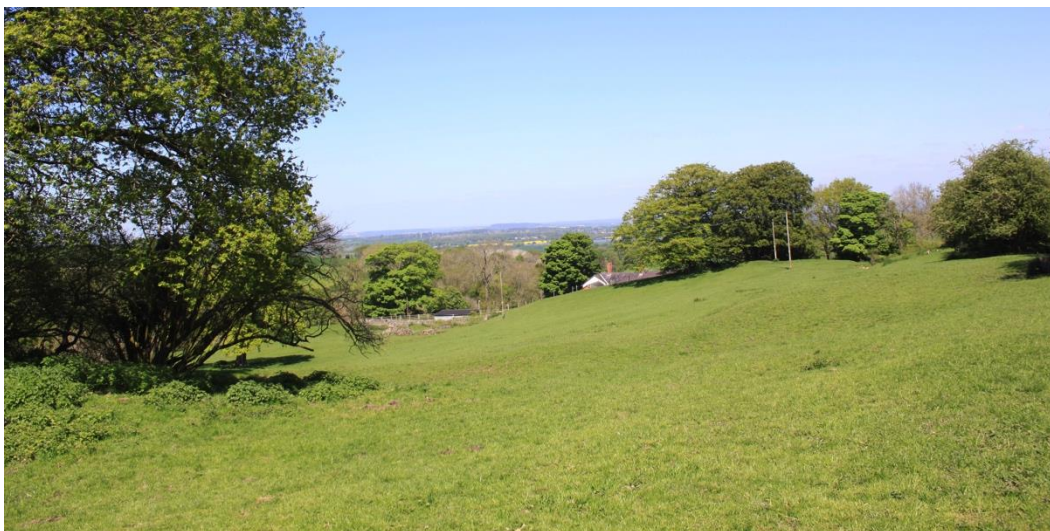
Figure 10. An ENE view across the eastern part of the outer enclosure, from a position in the outer bailey of the castle. The principal eastern entrance into the outer enclosure is located on the right of the image, between the deciduous trees in leaf. Note the north-facing slopes of the enclosure interior.

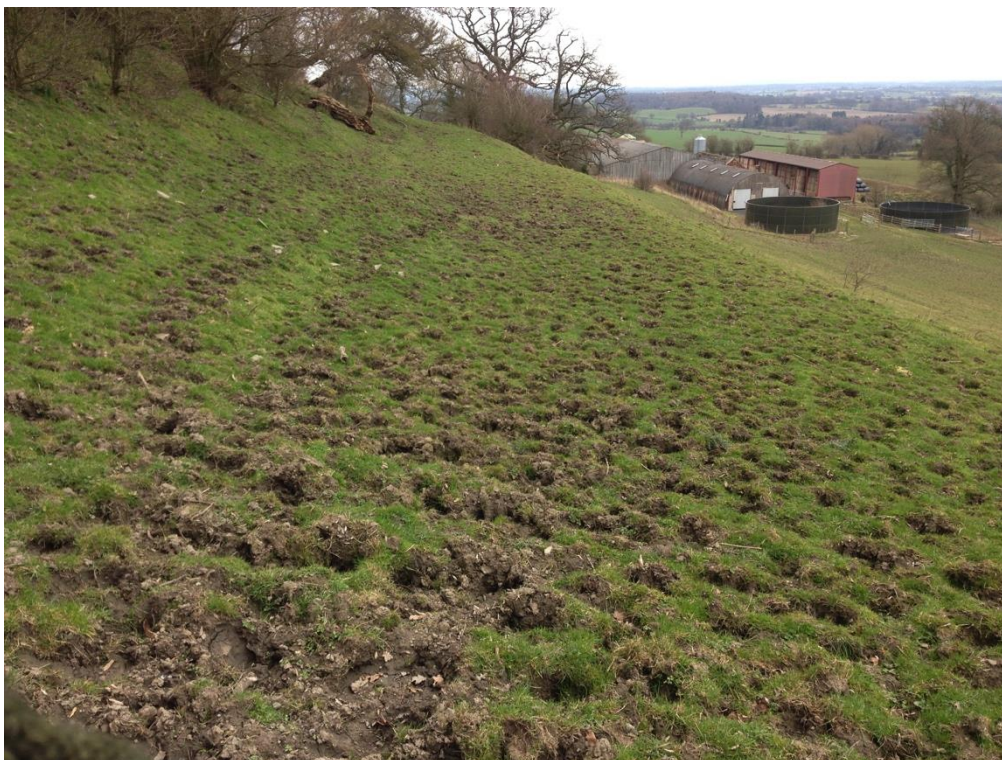
Figure 11. The section of ditch along the southern side of the outer enclosure, possibly in-filled to create a garden terrace c.1600. Cattle have heavily treaded the surface of this area. The farm buildings of Caus Castle Farm can be seen in the top right of the image.

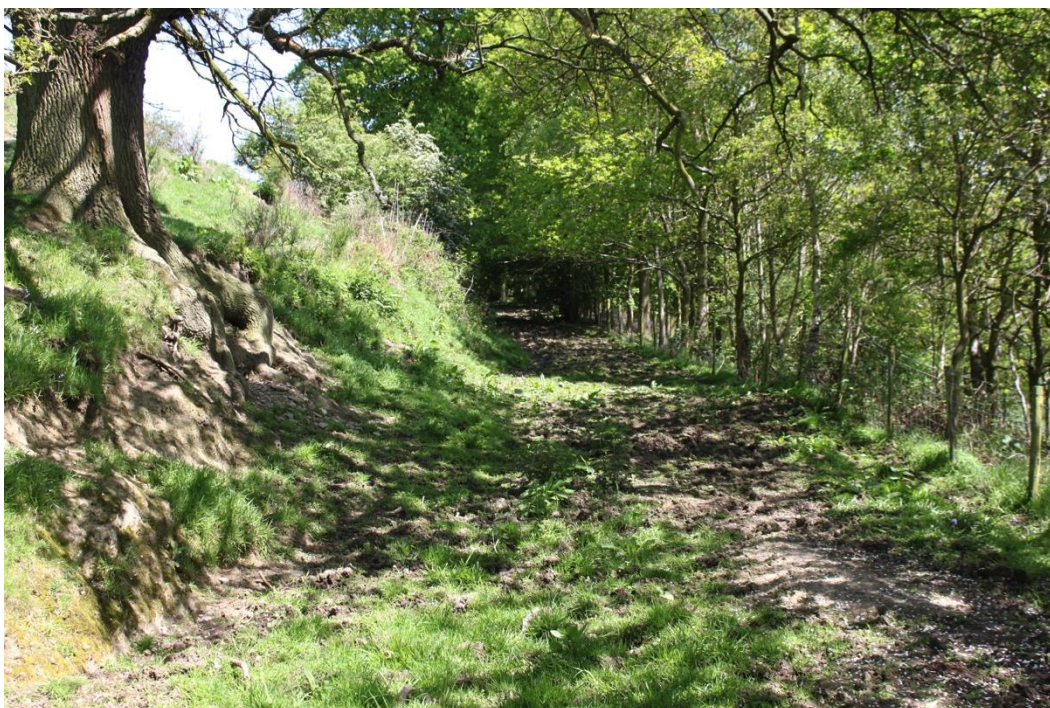
Figure 13. The sharp terrace of a track that runs along the south side of Caus, bypassing the settlement, and seemingly running eastward in the direction of Hawcock's Mount.

More unexpected was the identification of a deeply cut terrace running along parallel to the modern field boundary on the south side of Caus (Fig. 13). Running from the western side of the enclosure, the feature gradually reduces in size as the gradient of the hillside reduces. Its route cannot be detected beyond the environs of Caus, but given its orientation it is tempting to see it as the remains of a well-used route-way toward Hawcock's Mount. Interestingly, this deeply-incised track would have bypassed Caus, not unlike the possible track running parallel to the outer-enclosure perimeter on the north side of the site.
