# SURVEY AND RECORDING AT PICTON CASTLE, PEMBROKESHIRE, 2023

Prepared by Heneb – Dyfed Archaeology  
For: Castle Studies Trust

RHIF YR ADRODDIAD / REPORT NO. 2023-32  
RHIF Y DIGWYLLIAD / PROJECT NO. 130011

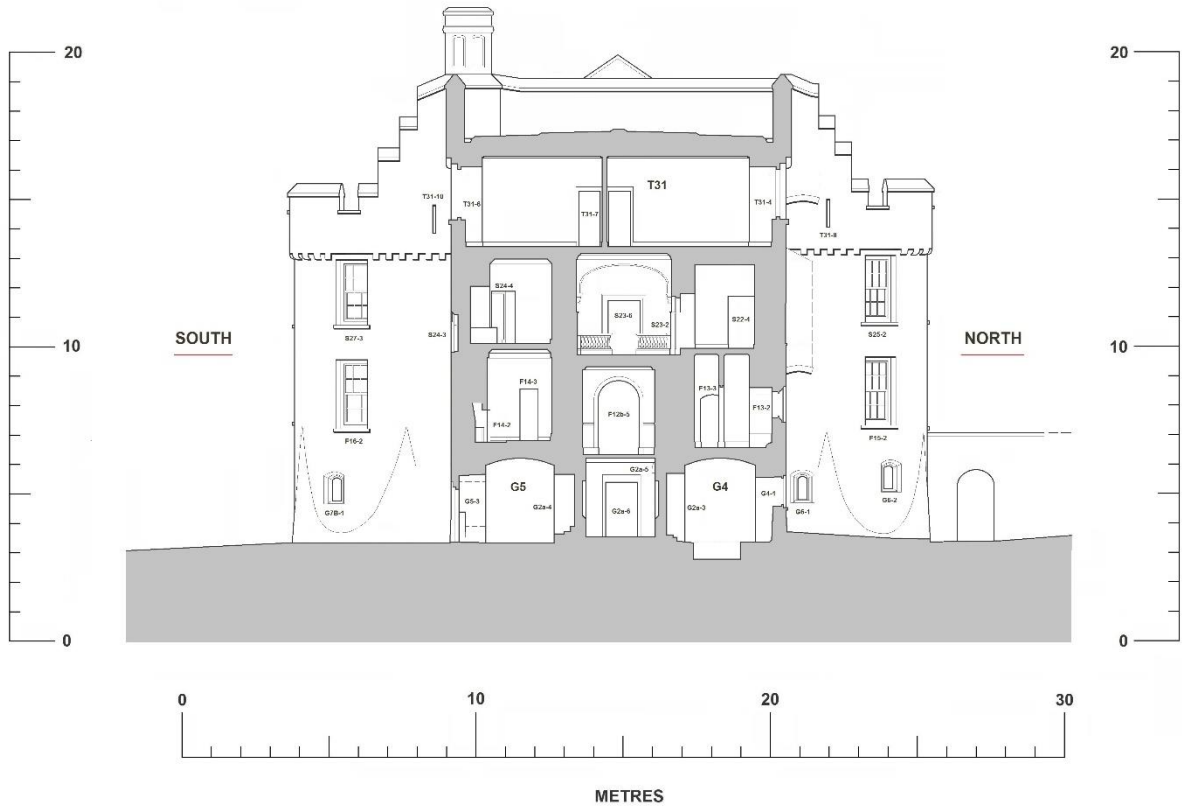
Fig. 4: Transverse section through Picton Castle gatehouse, facing west

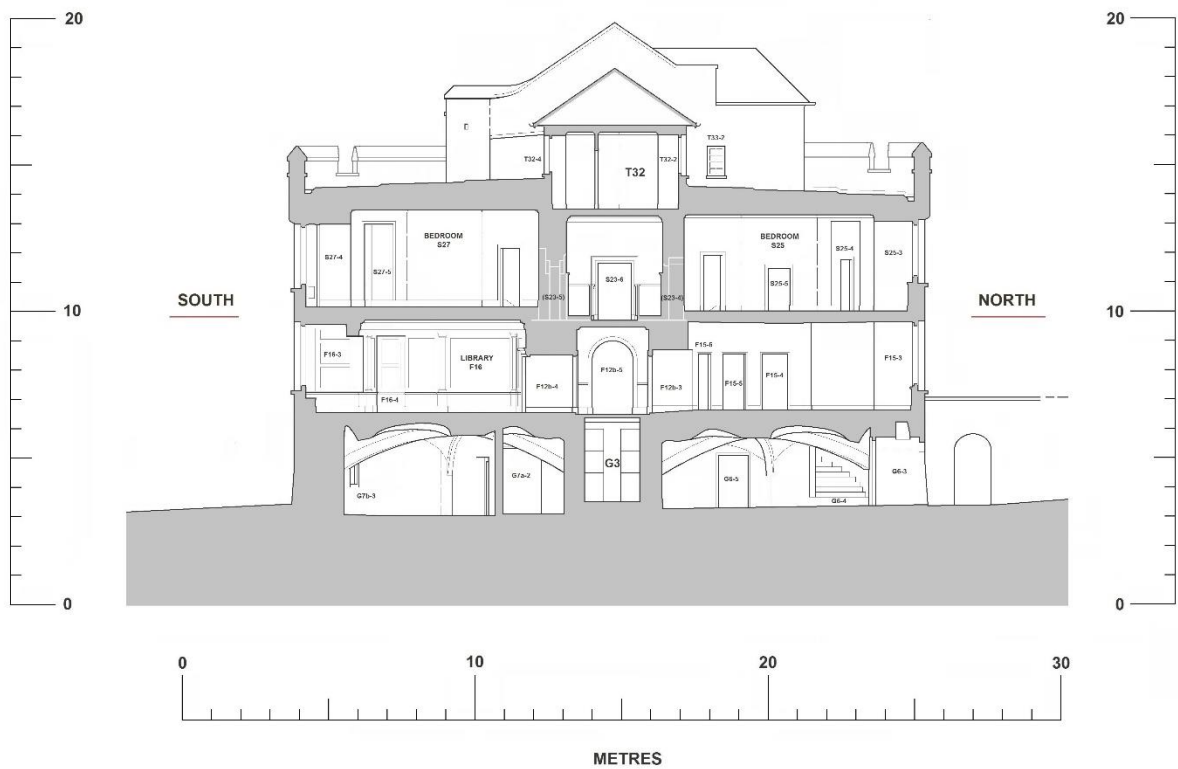
Fig. 5: Transverse section through Picton Castle east towers, facing west

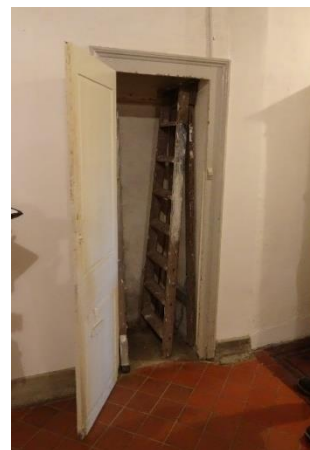
*Fig. 86: Cupboard (former entry) G11d-1 at the east end of corridor G11d, facing east*

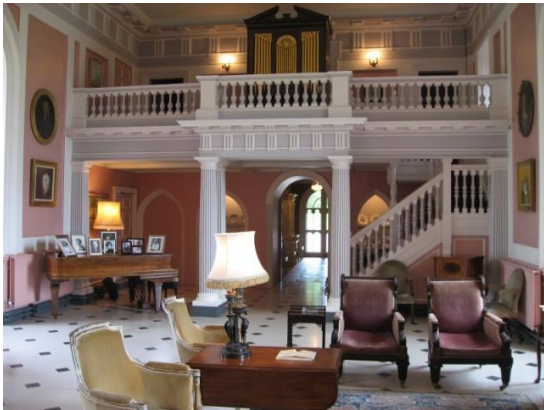
*Fig. 98: General view of the Great Hall, looking east showing eastern openings and gallery*

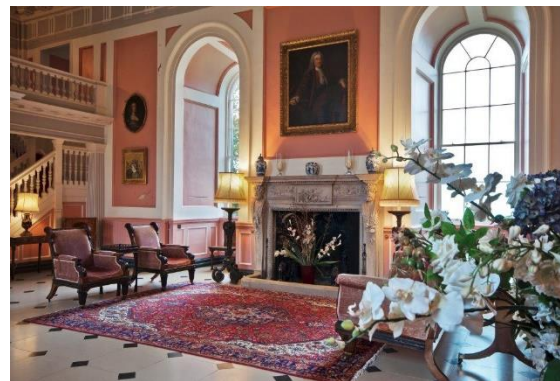
*Fig. 103: Great Hall south wall, showing windows F17-9 and F17-10, and fireplace F17-11*

West of the screens passage, the hall proper is lit by a two tall windows in each of the side walls (F17-7 – F17-10; Fig. 103). From the 1790s in their present form (see Sections 6.4 and 6.5.3), they were adapted from late fifteenth-century windows shown in c.1740, 1779 and c.1794 (Figs. 8, 11 and 12) and described in Section 4.5.1 below. Two-centred (relieving) arches are visible externally, above the two north wall windows (Fig. 24), but while windows were clearly part of the early fourteenth century design, the shape and size of these arches suggest they may relate to the fifteenth-century refenestration. They presumably replaced windows in the same location, which may have been somewhat smaller; there is no evidence for any further Hall windows in the fabric.

Between the two southern windows is a fireplace F17-11, with a mid-eighteenth-century chimneypiece (Fig. 103). We cannot be certain that it replaces a medieval original; the

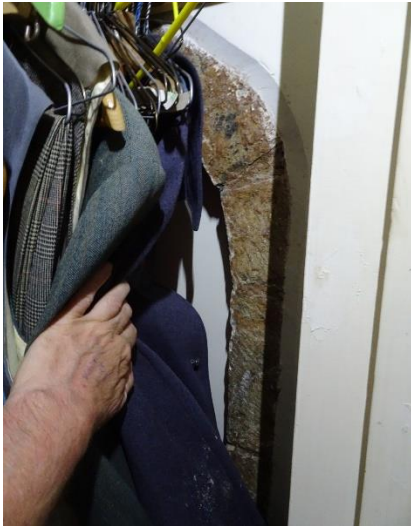
*Fig. 139: The head of blocked medieval passage doorway S26-2, now in a cupboard in room S25, looking northwest*

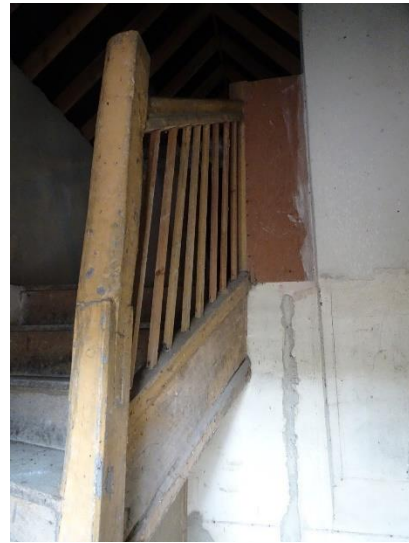
*Fig. 167: Continuation of spiral stair SSB towards attic, looking southeast*

At this level, the stair now features an inserted entry T33-1 from the eighteenth-century additional storey (Fig. 164), above which it continues for half a turn towards the Northeast Tower parapet; the risers have been replaced in timber (Figs. 166-7). Midway up is an internal recess in the west wall of the caphouse, representing the blocked medieval doorway onto the Great Hall north wall parapet (Fig. 166); the parapets appear to have occupied the same level throughout the castle, meaning the doorway must have incorporated three steps up. A small slit-light SSB-4 in the same wall, with a splayed, segmental-headed embrasure, appears to be medieval (Figs. 23 and 166). The stair emerges onto the Northeast Tower parapet through a plain doorway in the north wall (Fig. 166); this wall is thin, and entirely modern (twentieth century?), but presumably replaces a medieval predecessor. The stair now continues upwards towards the later attic, with timber risers (Figs. 166-7).

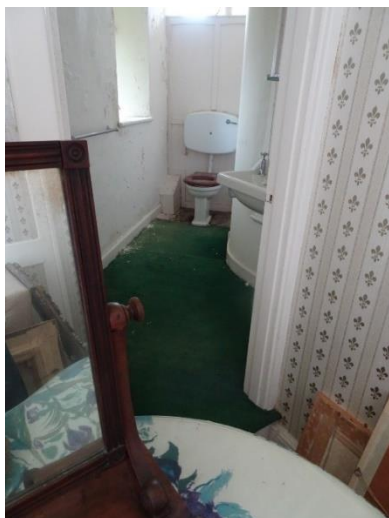
*Fig. 168: Post-medieval doorway T34-1 from the additional storey onto spiral stair SSC, looking southwest into stair passage T34*

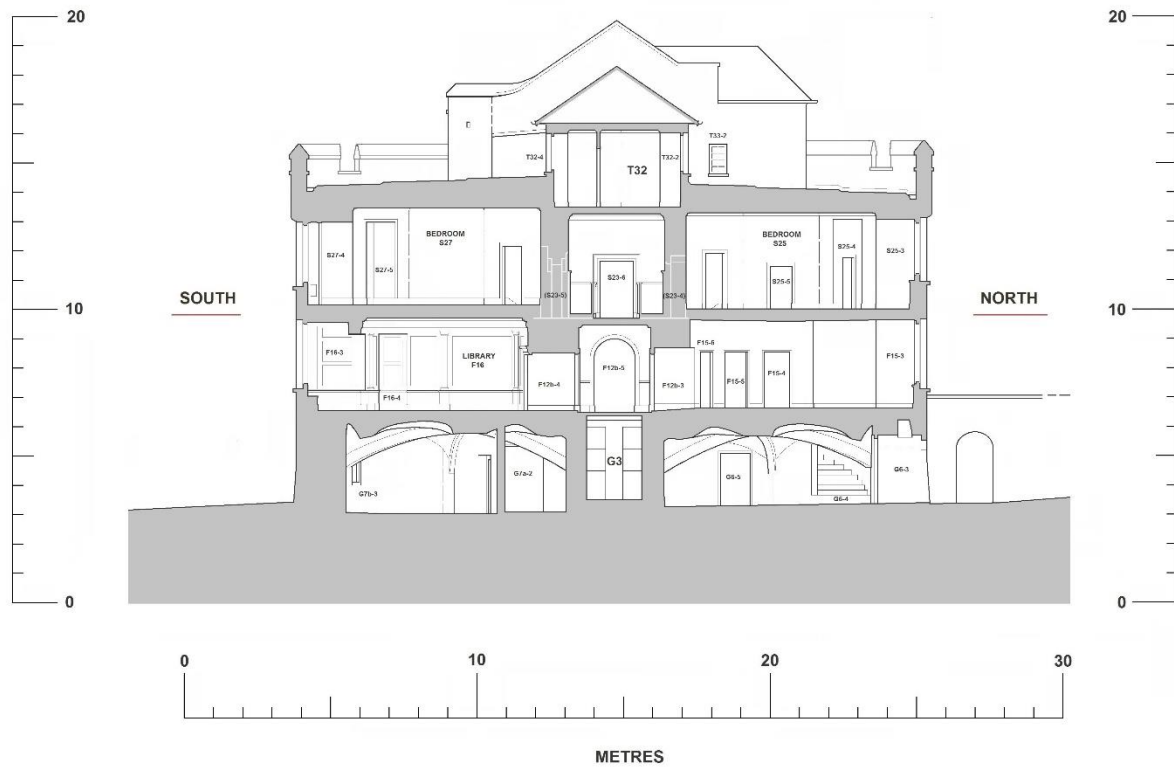
Fig. 178a: Transverse section through Picton Castle east towers, facing west – modern

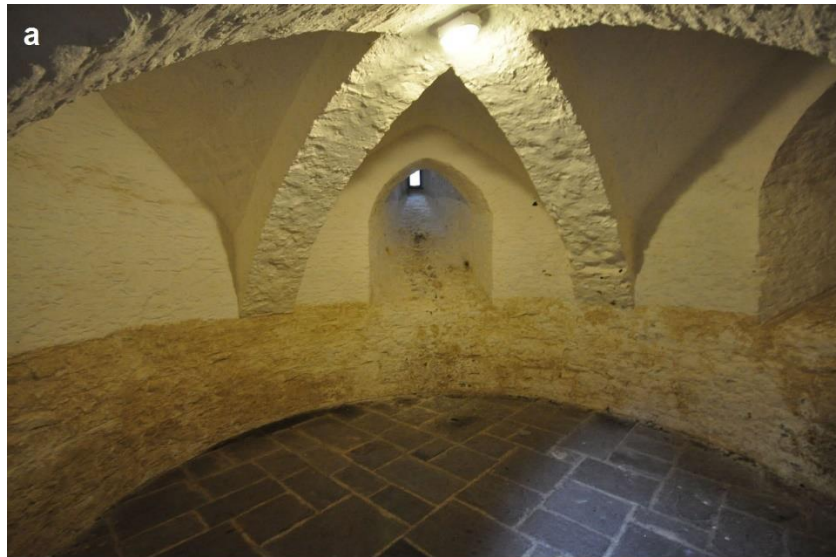
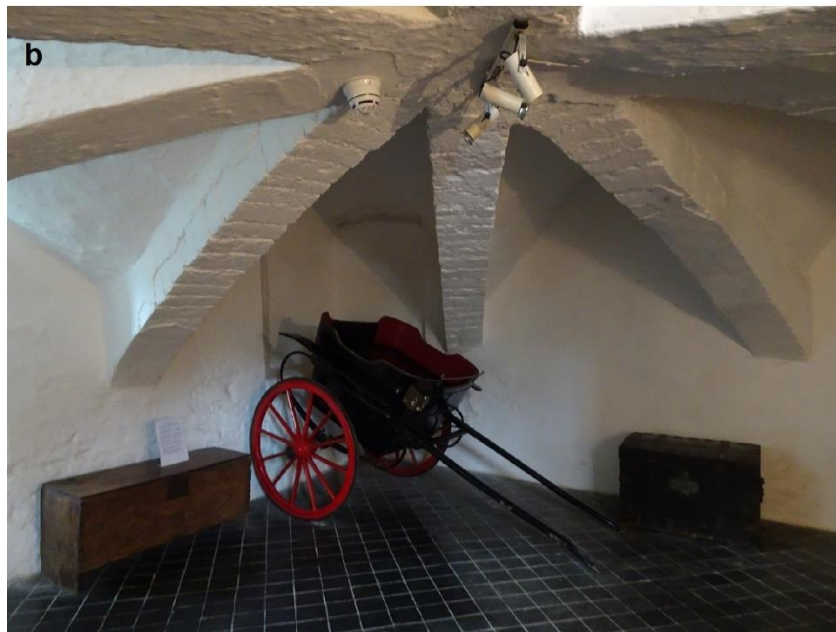
*Fig. 196: Low rib-vaults with a deep extrados at a) Castell Coch (Glam.), late 1260s-70s;  
b) Picton Castle northeast tower*

The closest comparanda for the low undercroft vaults in Picton's east towers are at Gilbert de Clare's Castell Coch, Glam., from the late 1260s-70s (Davis 2000, 213; McLees 2005, 9). The Kitchen Tower there shows a low quadripartite vault with robust, square-sectioned ribs, as at Picton, while in both castles the extrados of each rib is built up for some distance before the springing of the vault panel (Fig. 196). Broadly comparable vaulting was also employed by Clare in the inner west gatehouse at Caerphilly, Glam., perhaps from c.1271 when the castle was started anew (Renn 2018, 229). Rib-vaulting, during this period, was otherwise very infrequent in west Wales – an exception is work from c.1300-10 at Newport, Pems. (Fig. 197) – and where employed could sometimes take the form of superficial, 'bastard ribs', as in the Chapel Tower at Carew Castle, from c.1300 (discussed in Ludlow, forthcoming).

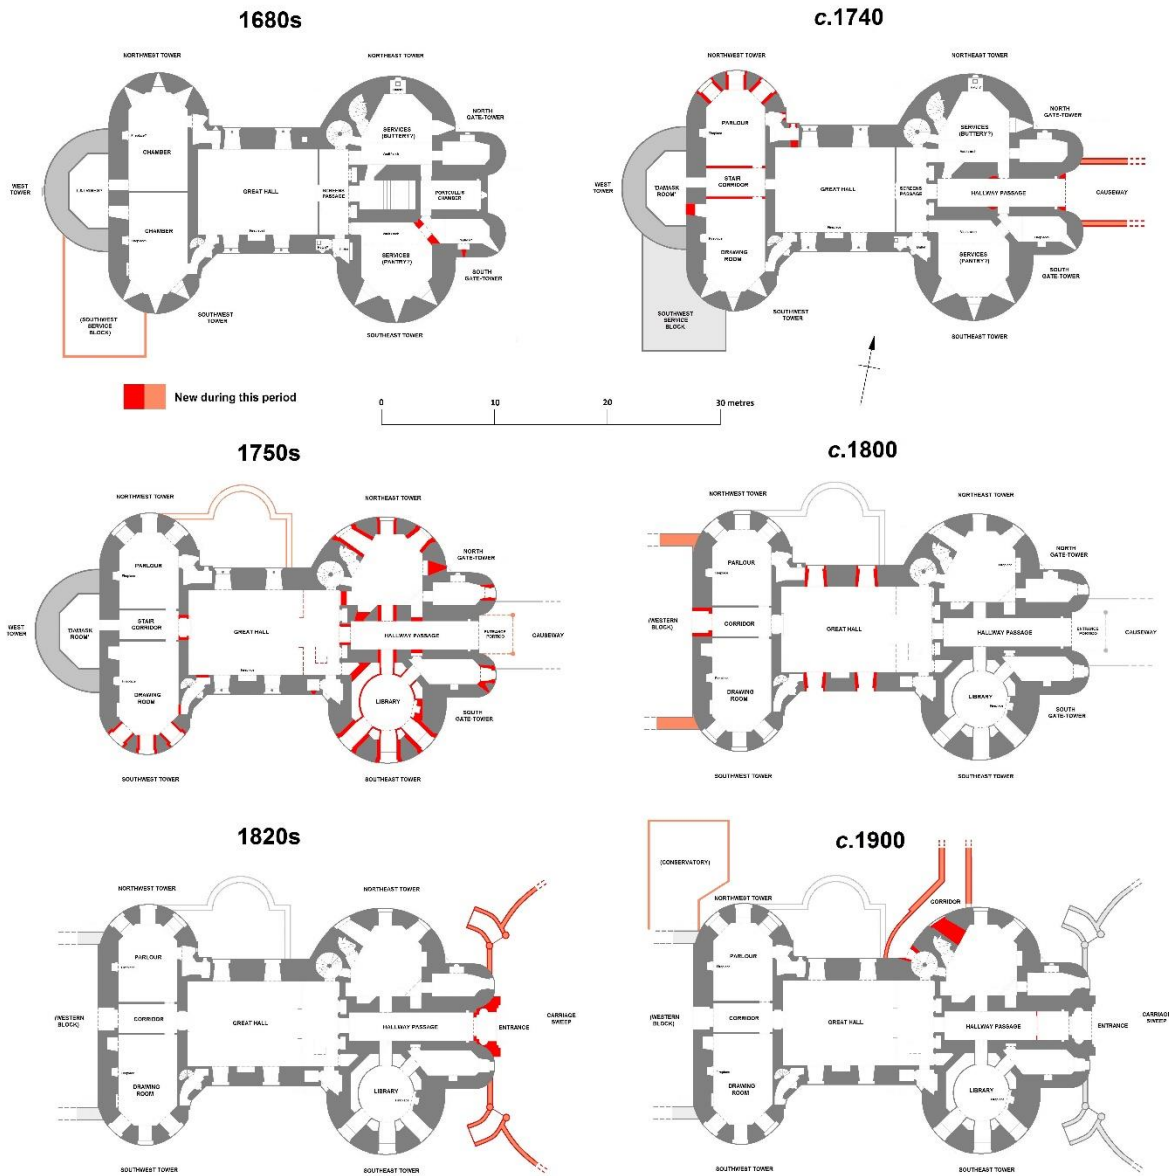
Fig. 206: First-floor plans of Picton Castle showing post-medieval development (1680s plan conjectural).  
New work at each period is shown in red
